CMS Pixel Chip PSI46 V2
- preliminary tests -

Cristian Gingu

Fermilab, February 2005

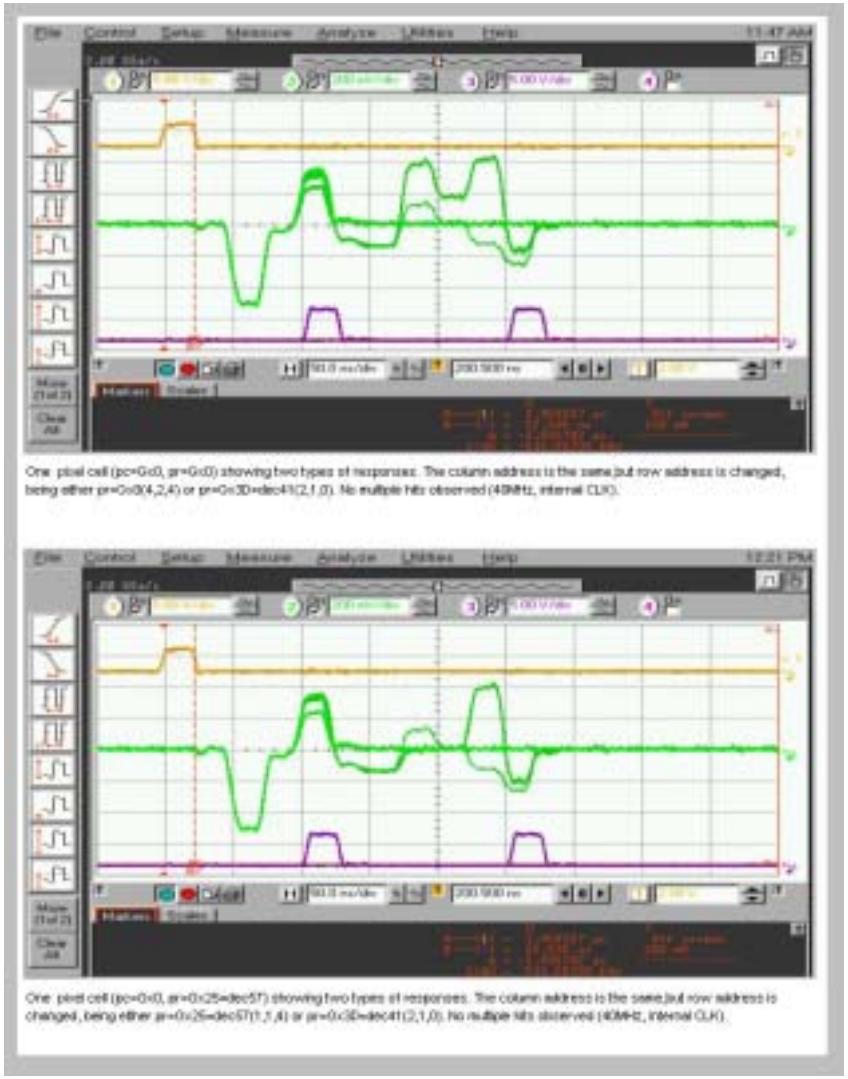
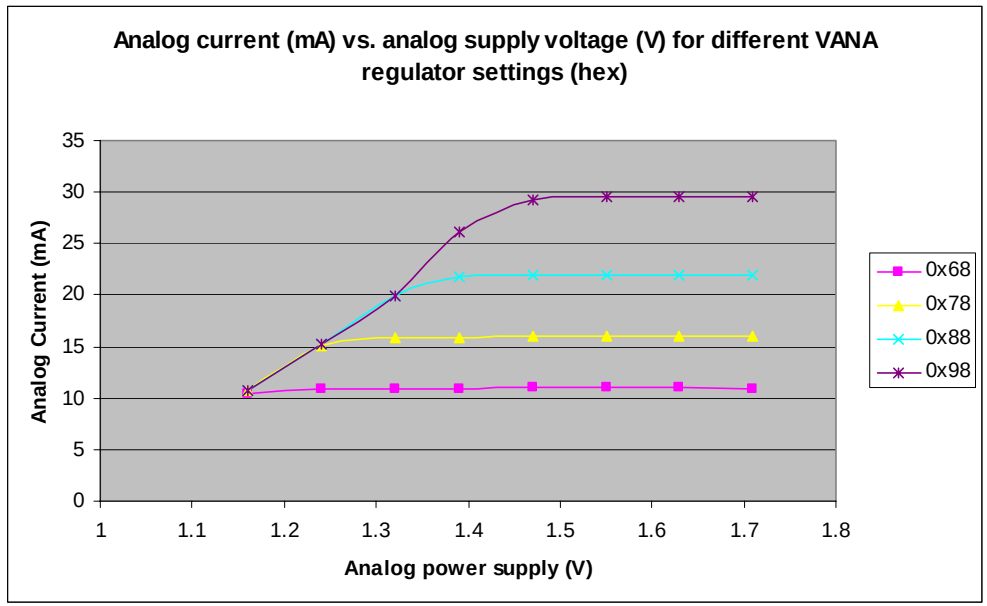
Multiple hit problem (power supply)

- The main issue we faced with V2 testing was the multiple hit problem, i.e. we calibrate and inject only one pixel, but more pixels are seen in the read-out (see left pictures).
- We thought first that the power supply voltages have not the necessary values (V1 didn't worked but for Vdig ~2V) so we did investigate the chips' power regulators influence (see below) on overall chip functionality/stability.
- There is no official specification. Eventually, after discussion with Roland H. we learned that their testing strategy includes a scan of Vana to determine a setting for which Iana~24mA. We didn't implemented this approach.

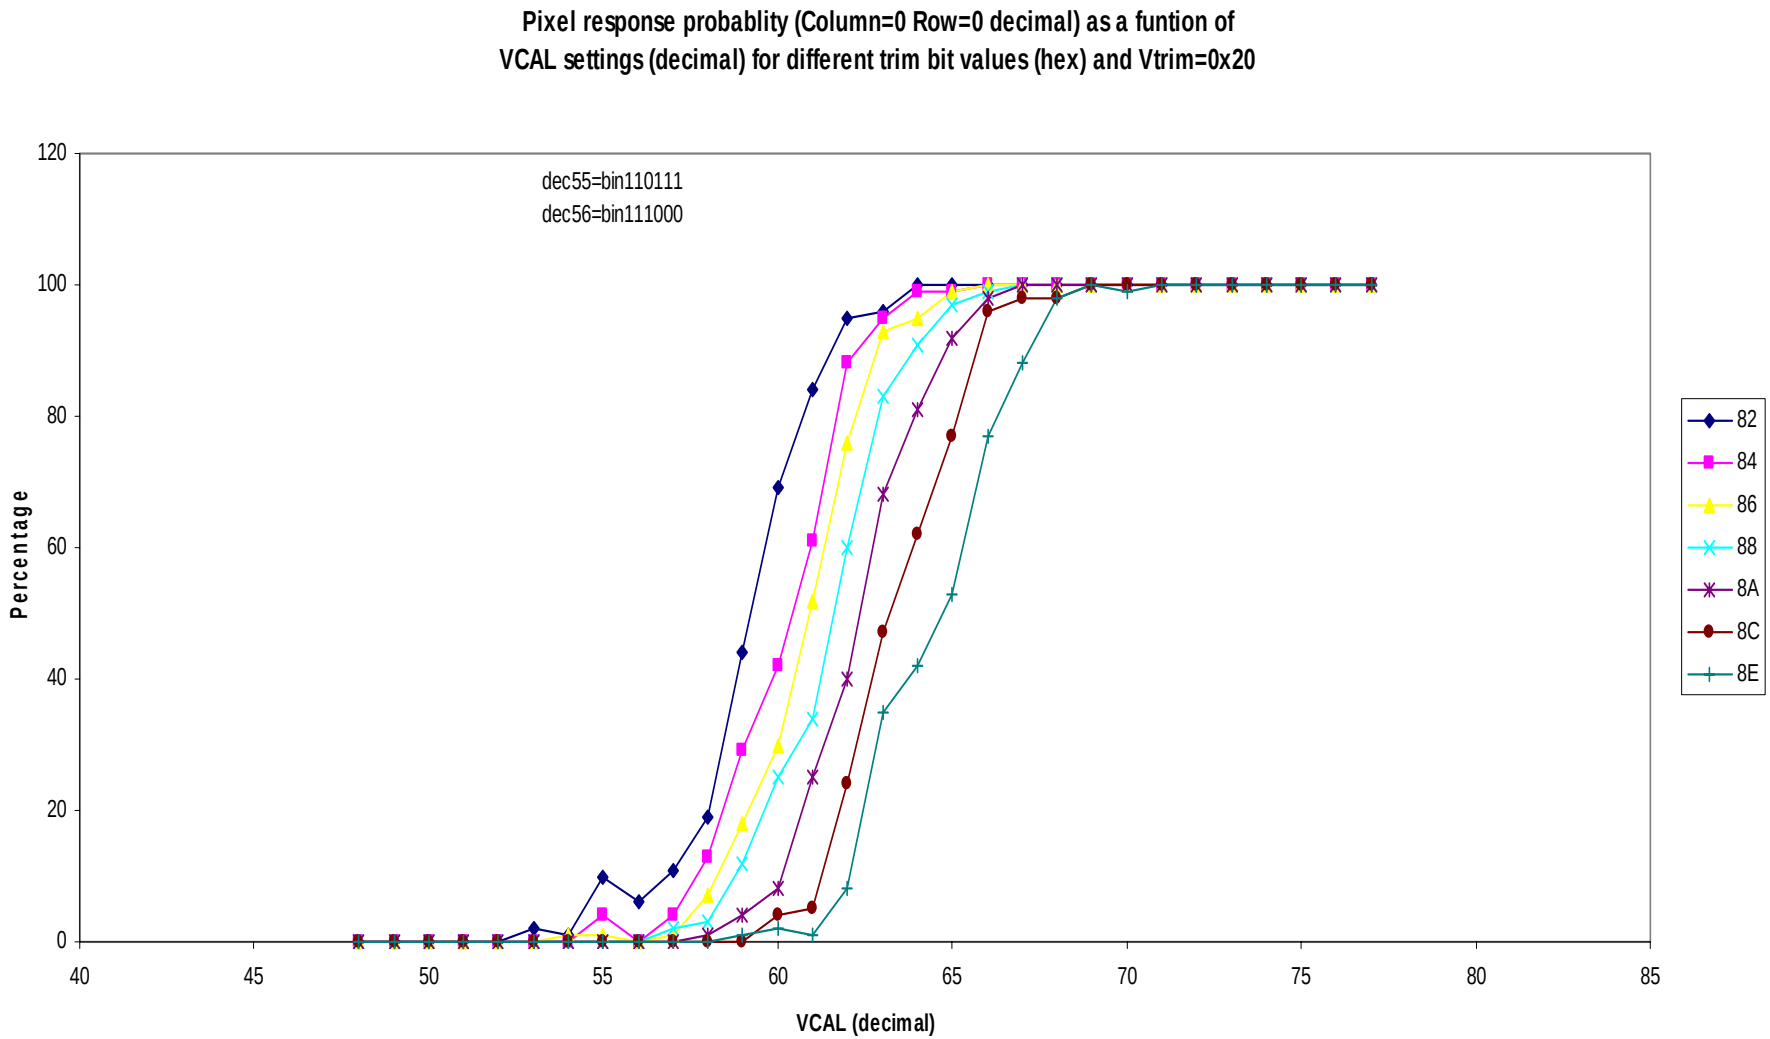
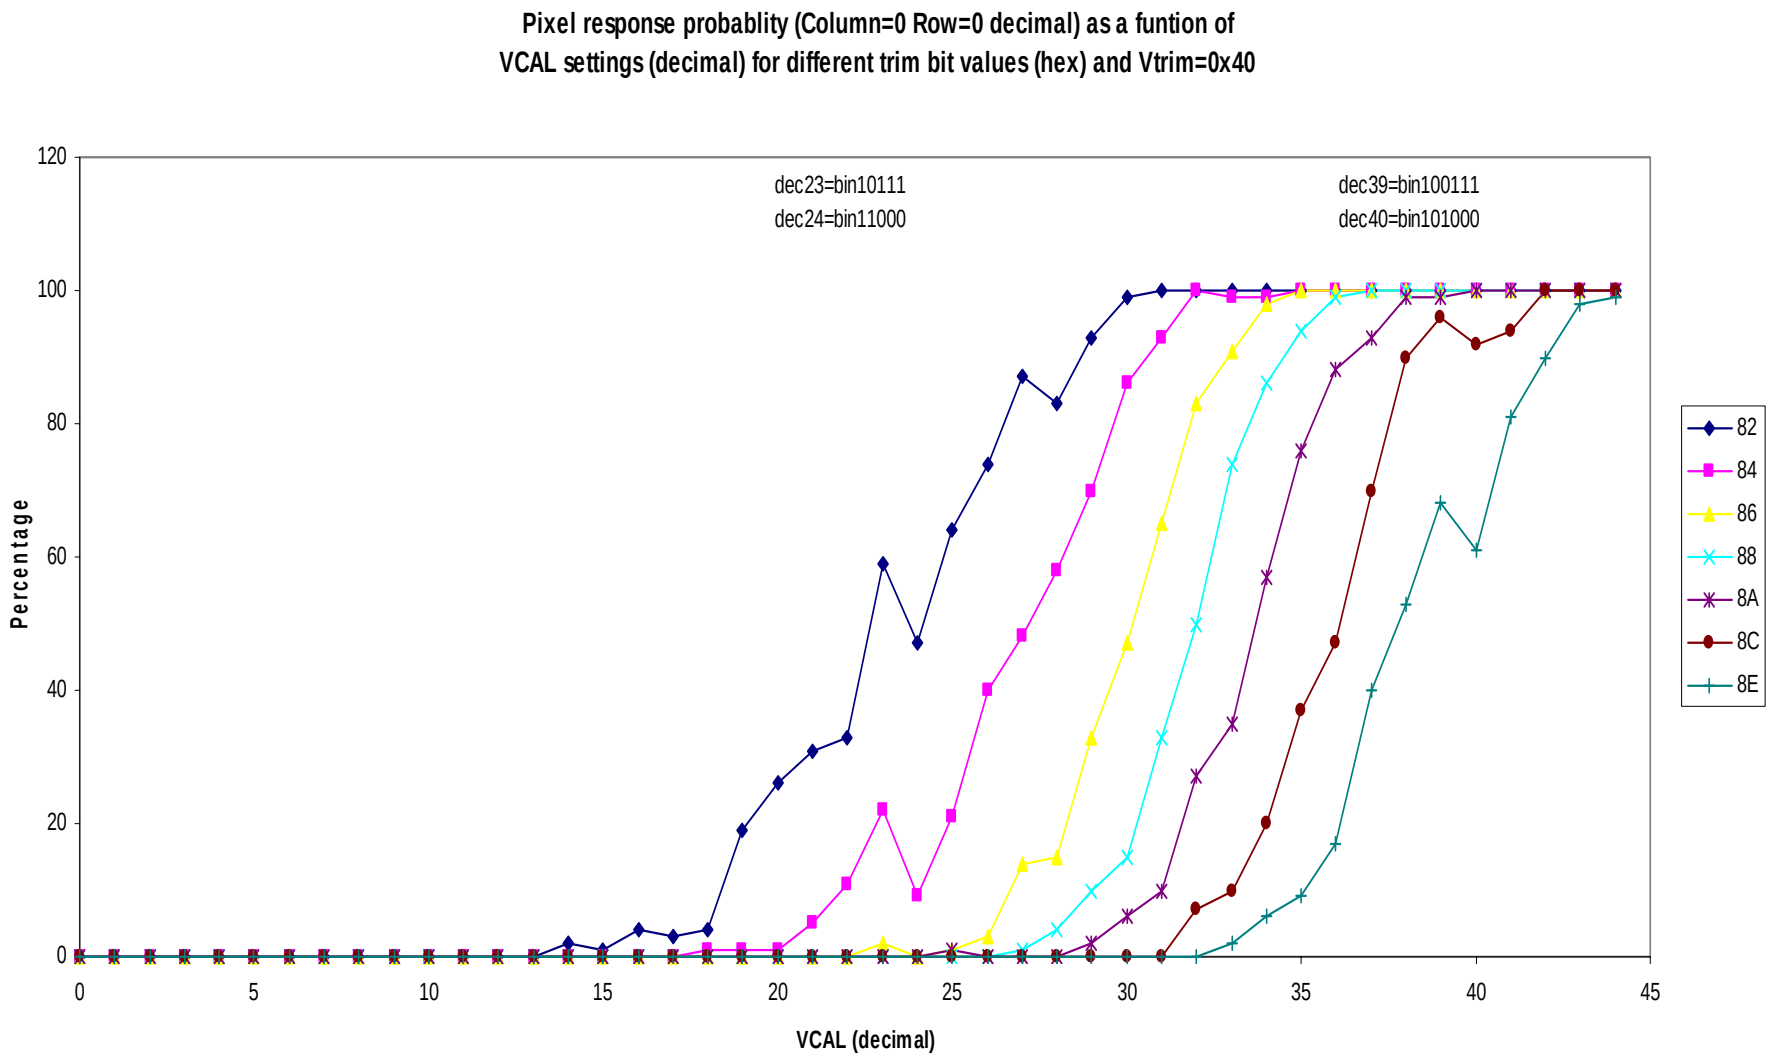
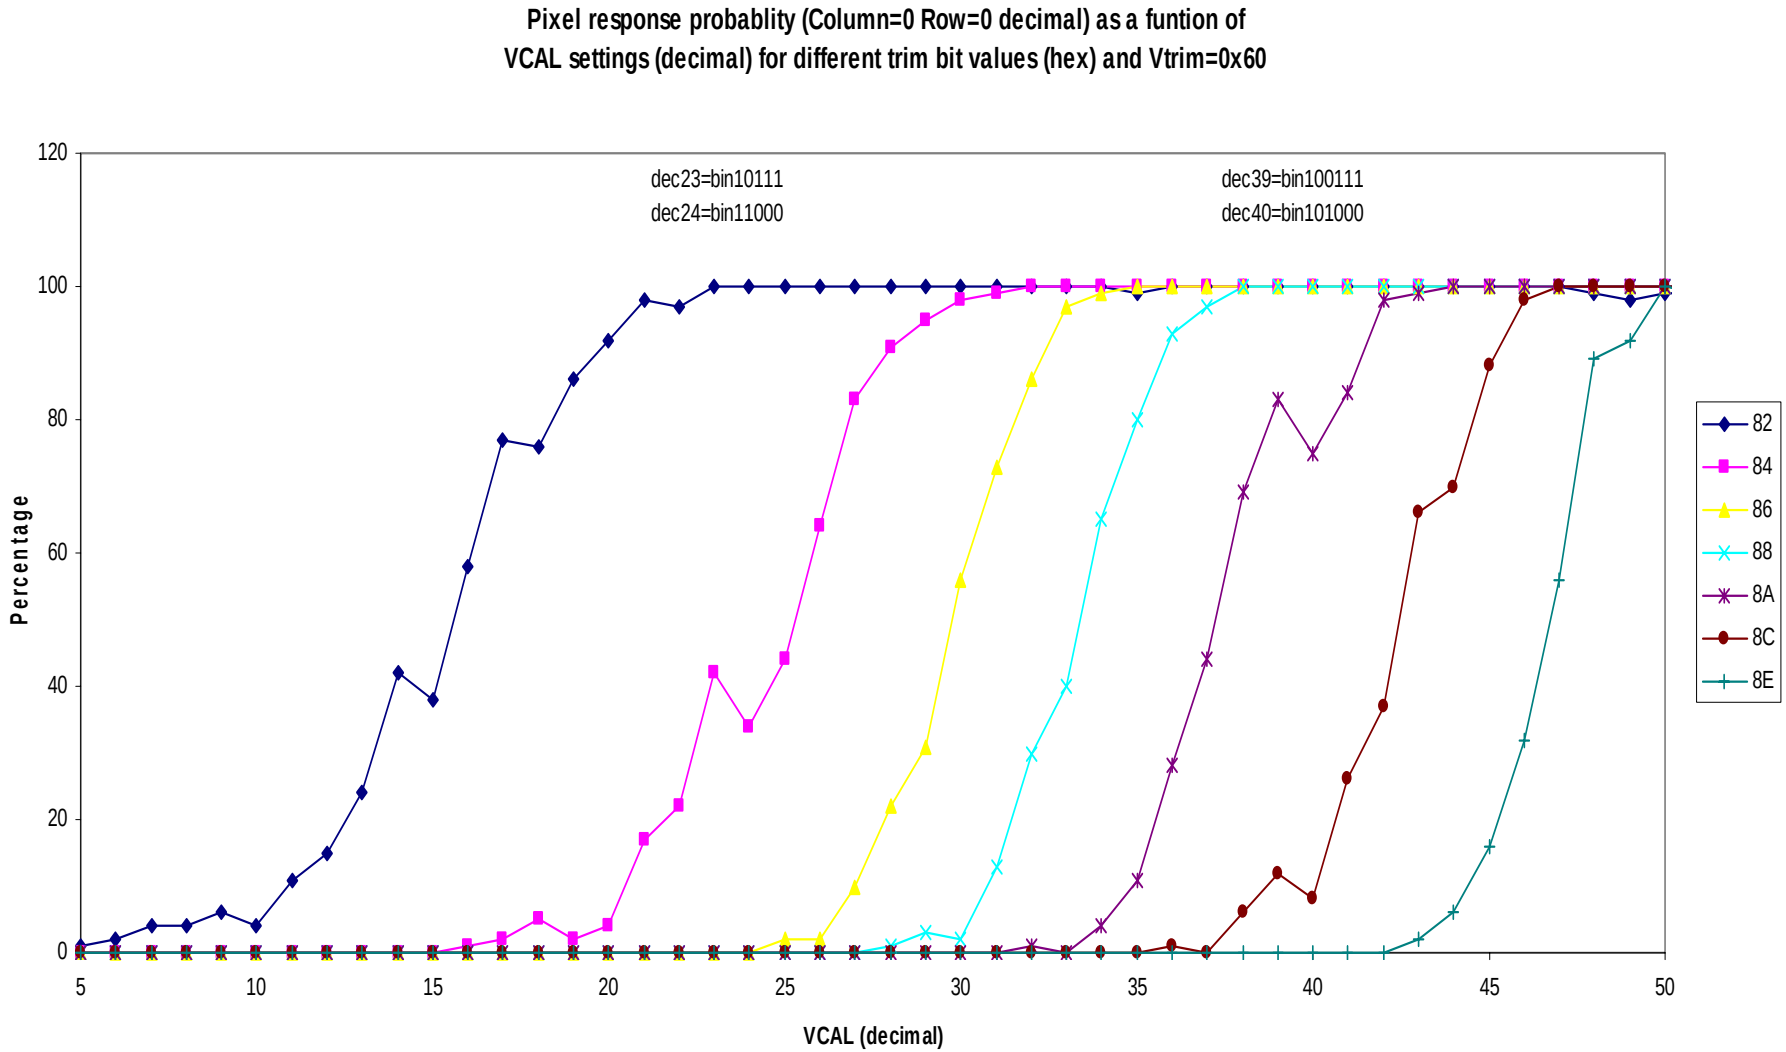
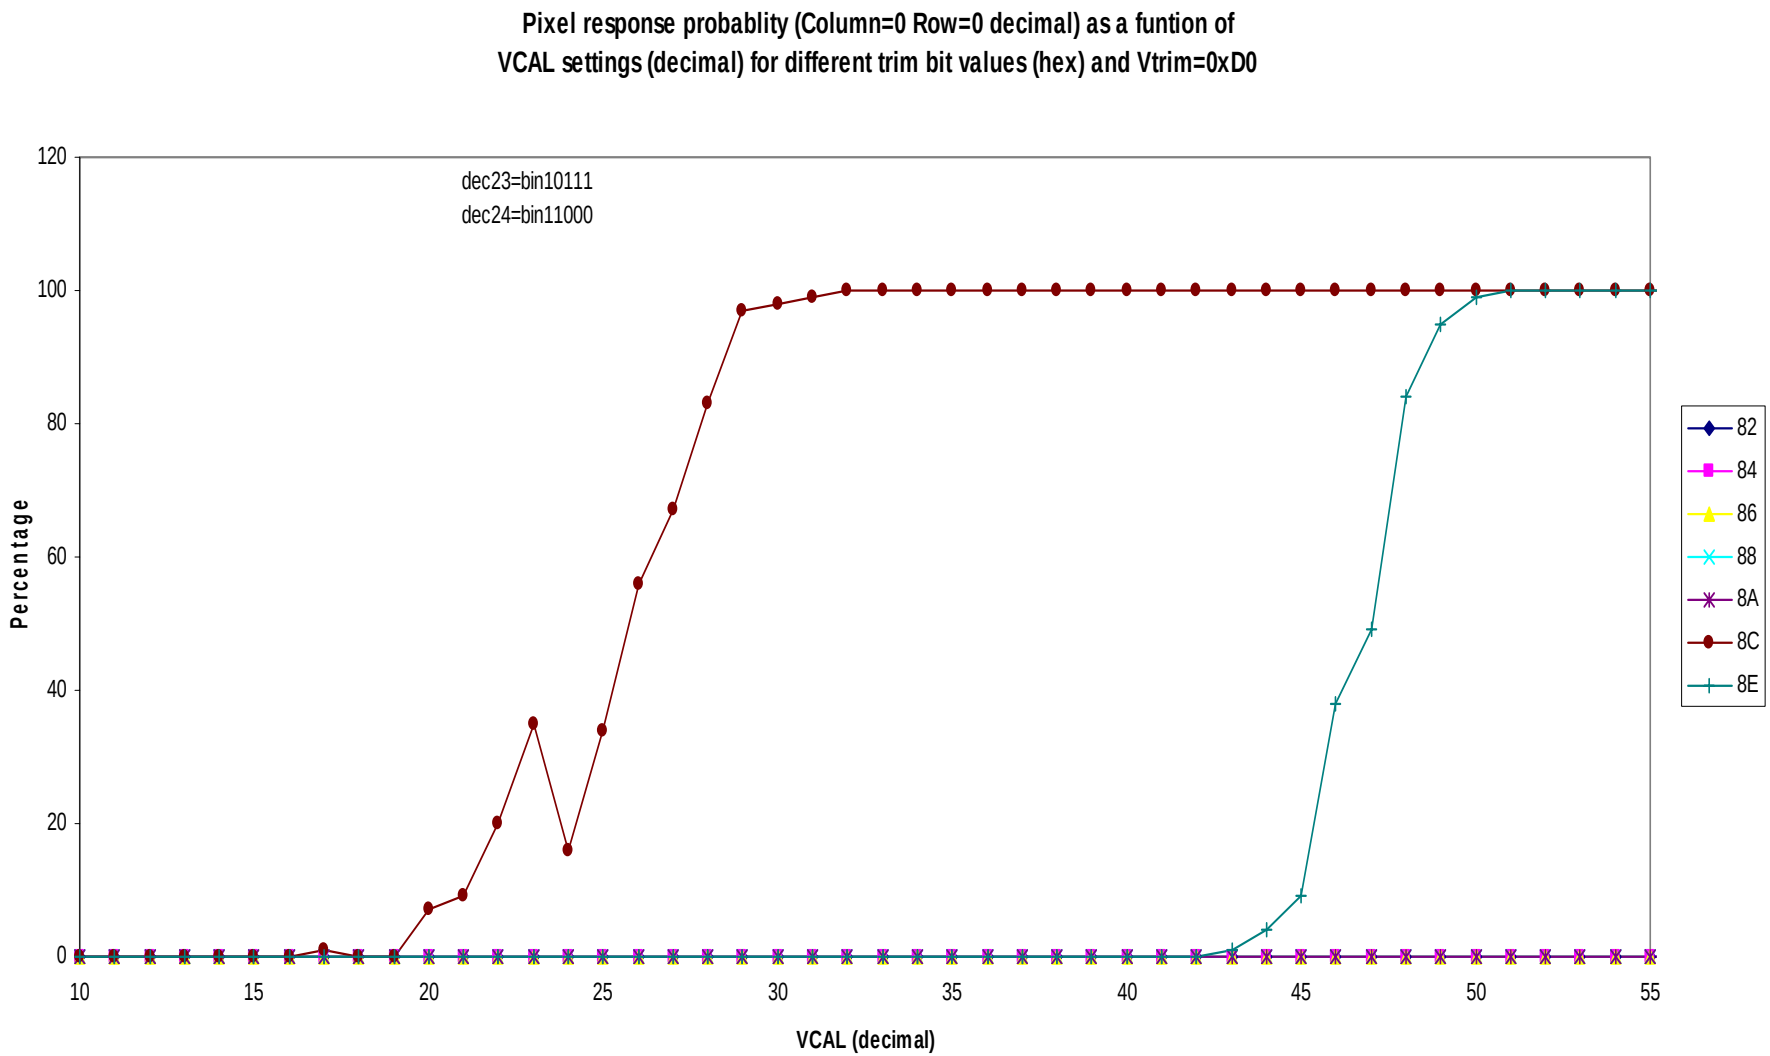
Pixel response dependence on Vtrim

- When Vtrim has quite high settings, say 0xD0 as in slide 9, the pixel shows a response only for trim bits 0x8C and 0x8E i.e. trim bits almost inactive (NOTE: the trim bits are 'active zero' so 0x8E means only the LSB is activated). So, in order to 'see' response when we increase the pixel threshold (by decreasing the trim setting to 0x8A, 0x88,… 0x82) we changed the settings as in slide 10: the VCAL range was increased from 280mV to 1800mV (using the new control bit from CTRL register) and the comparator threshold for all pixels (VthComp) was increased (VthComp setting decreased from 0x64 to 0x01).

Pixel response probablity (Column=0 Row=0 decimal) as a funtion of VCAL settings (decimal) for different trim bit values (hex) and Vtrim=0xD0 and CTRL changed from 0x00 (280mV) to 0x04 (1800mV) and VthComp changed from 0x64 0x01 (rising pixel threshold)

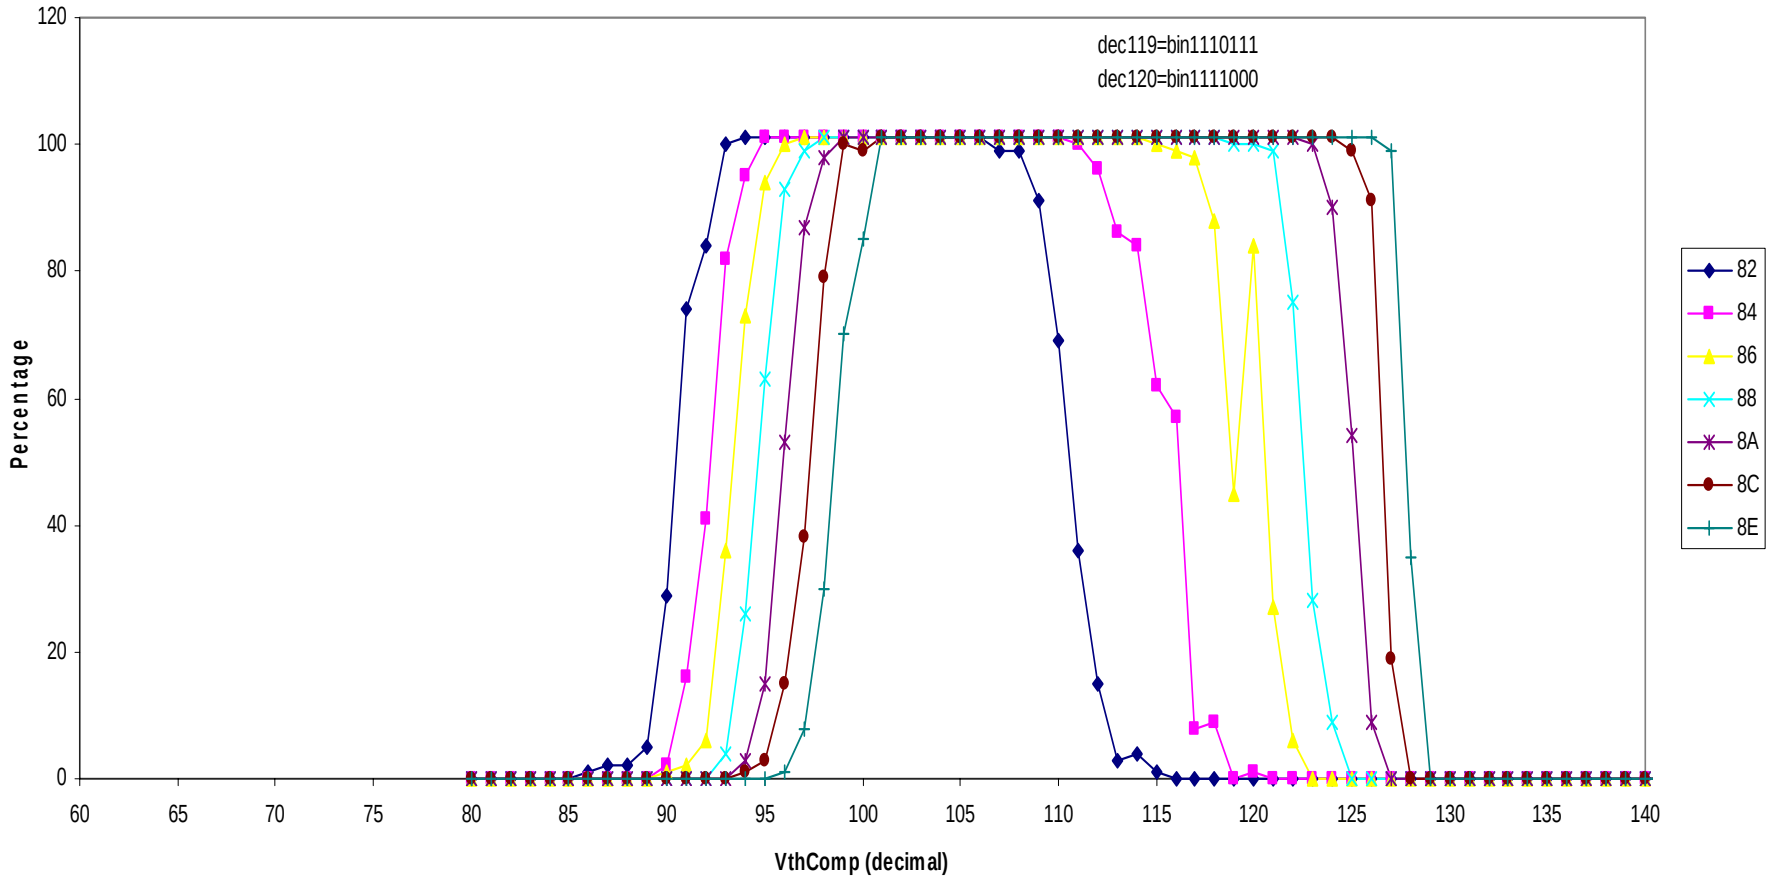
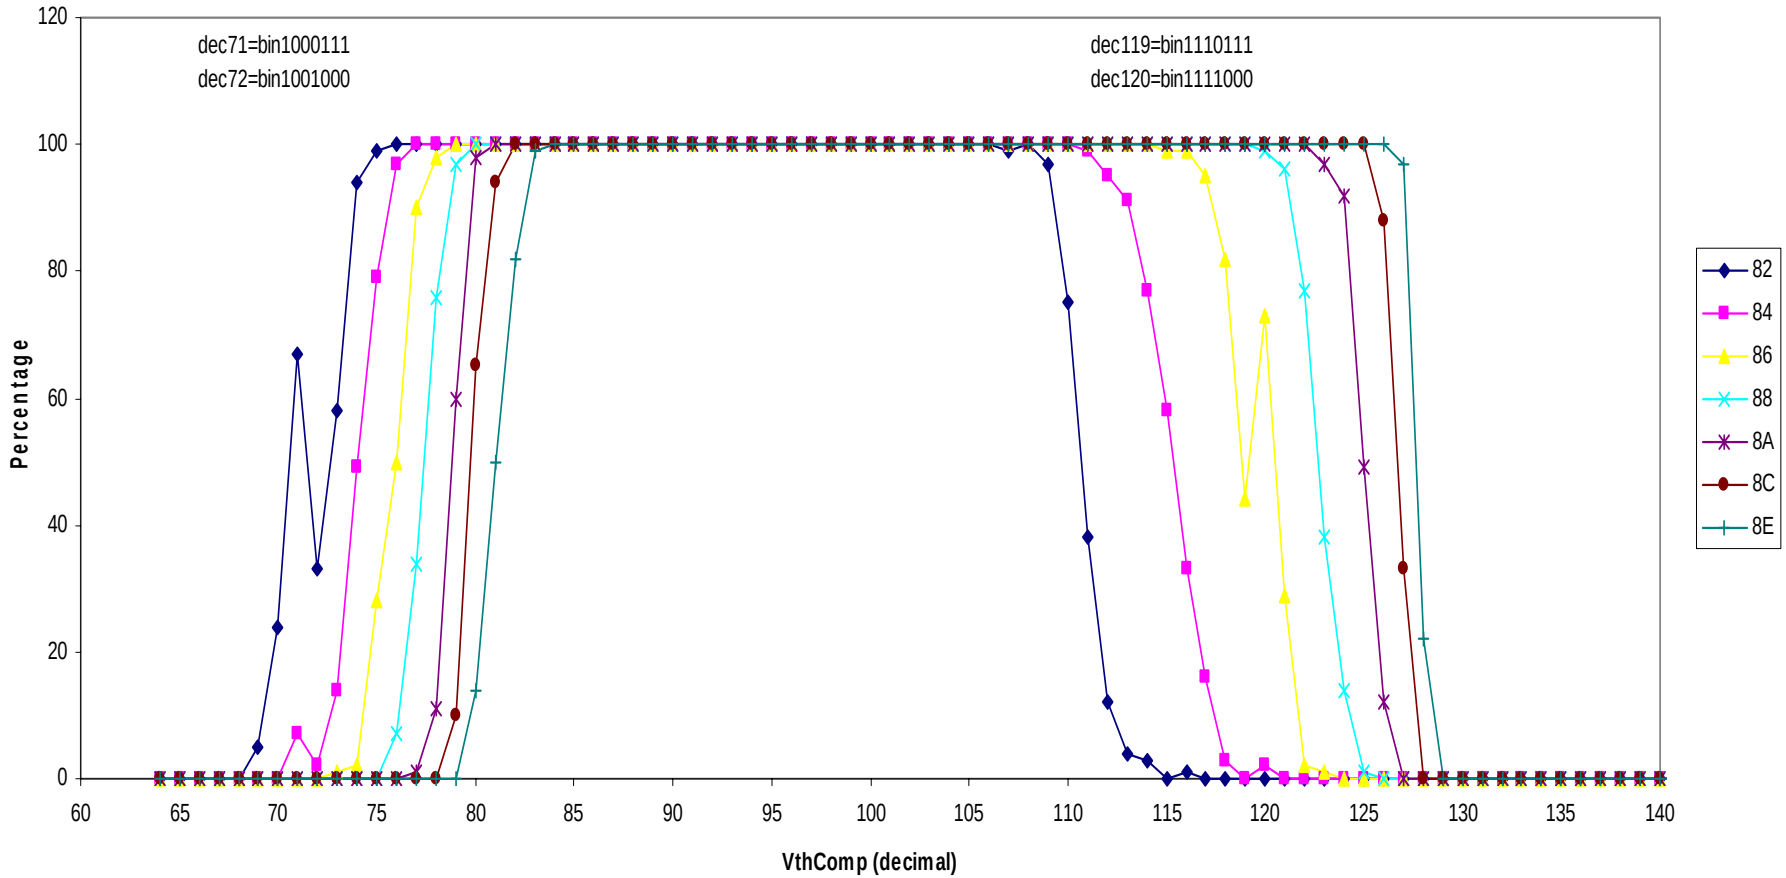
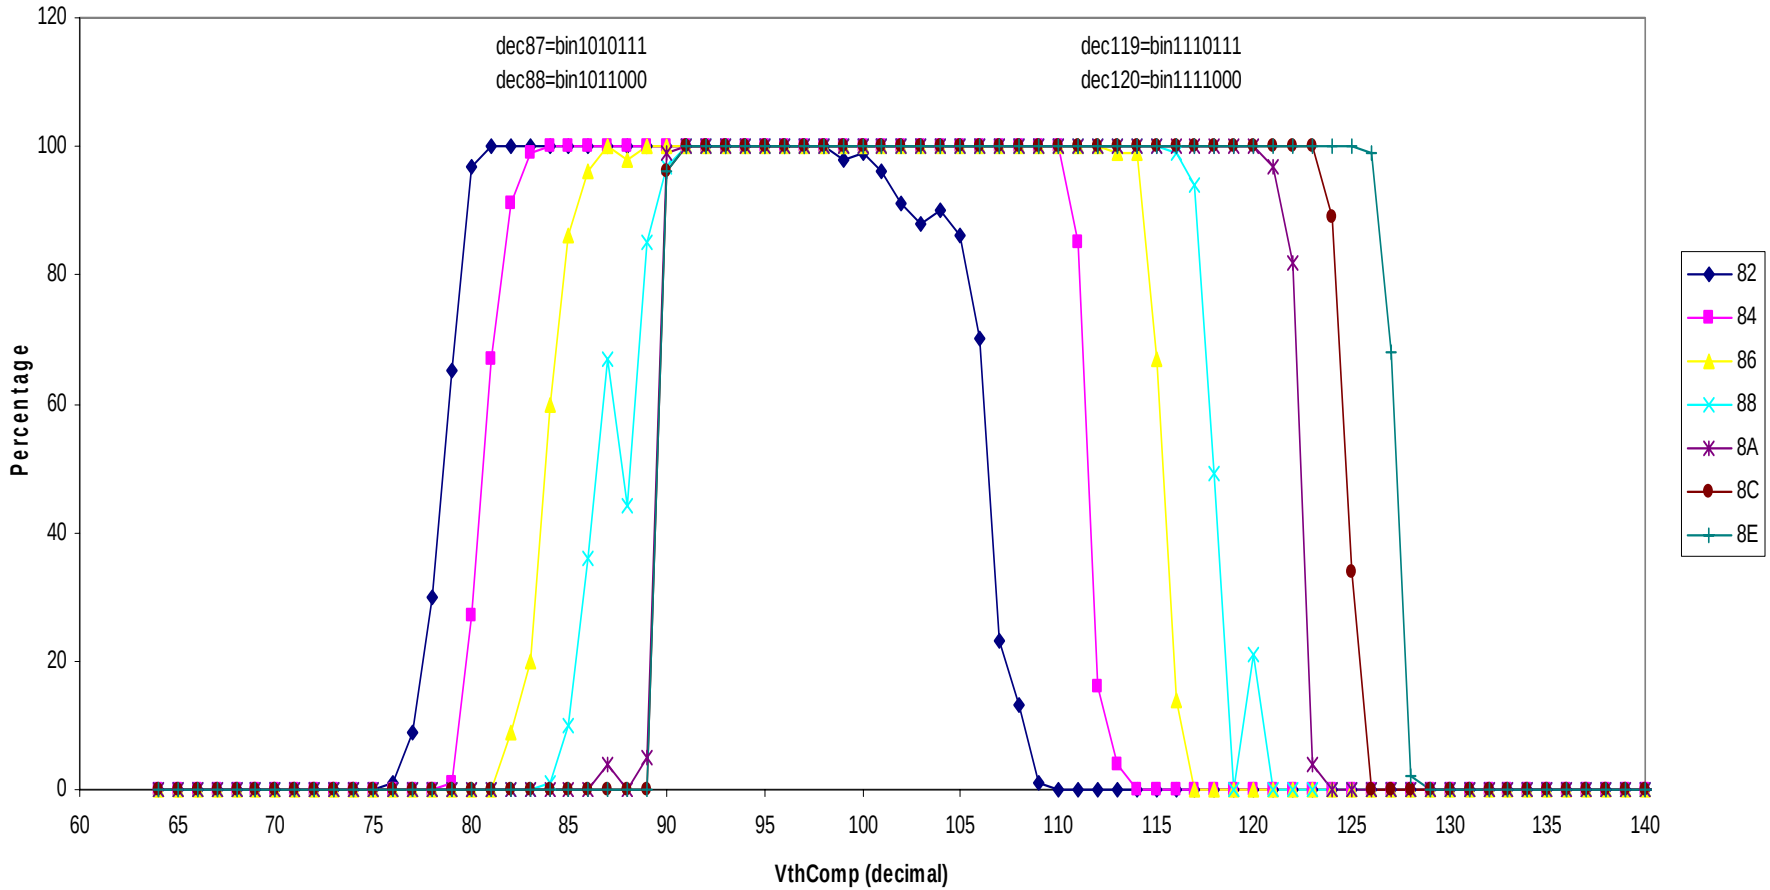
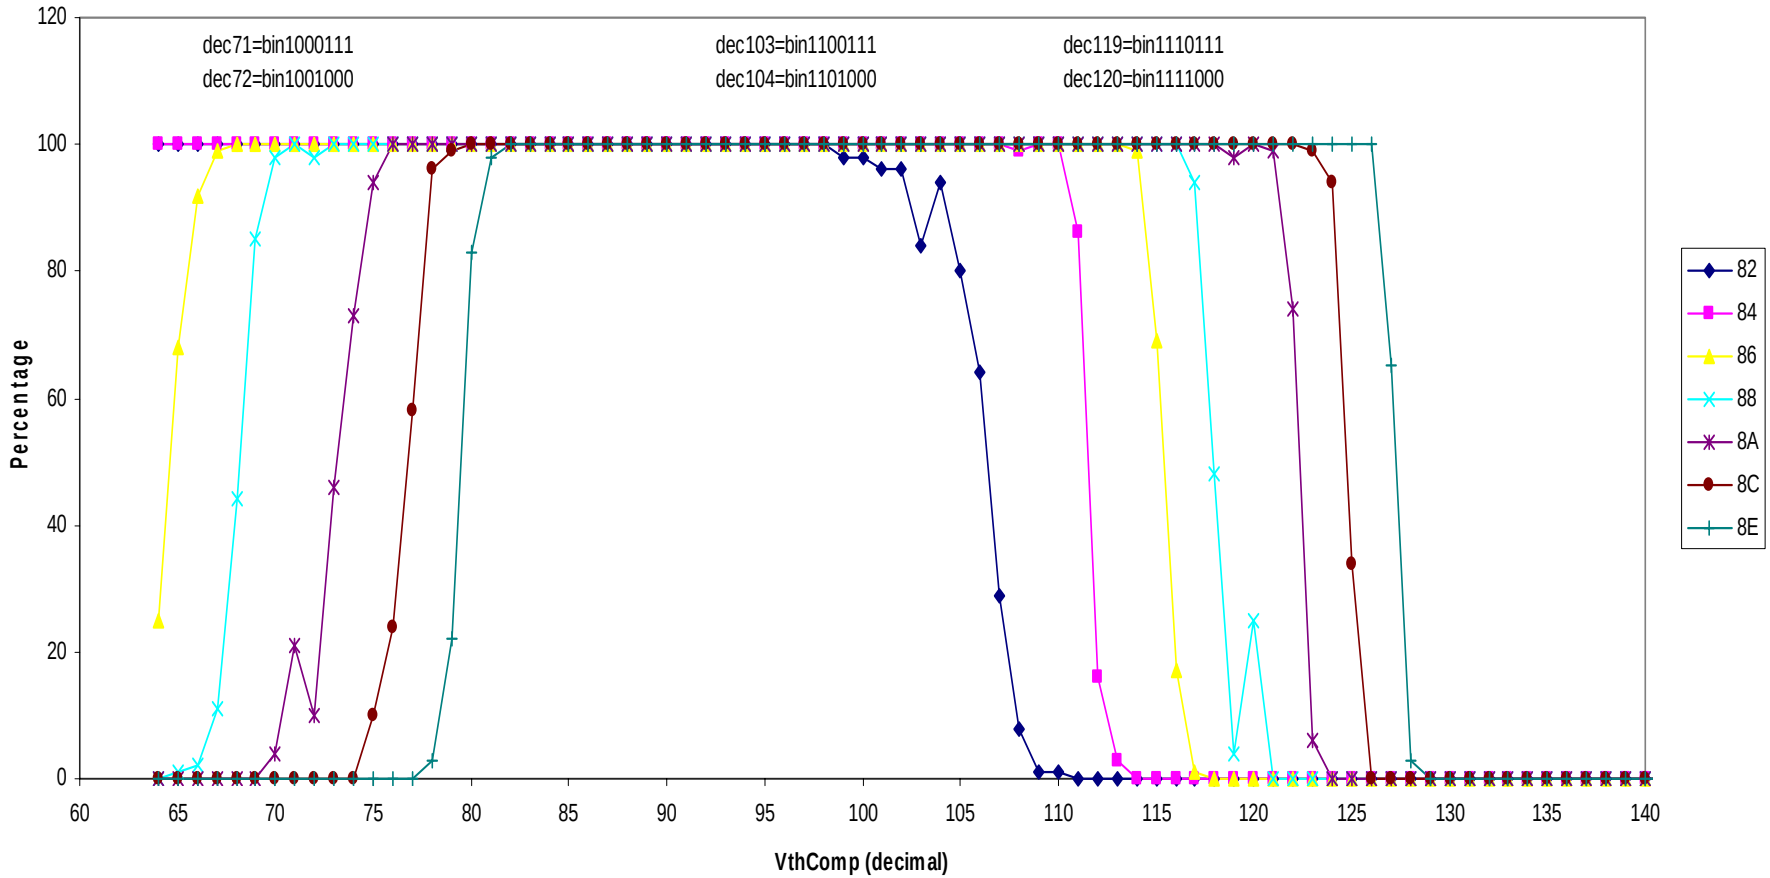
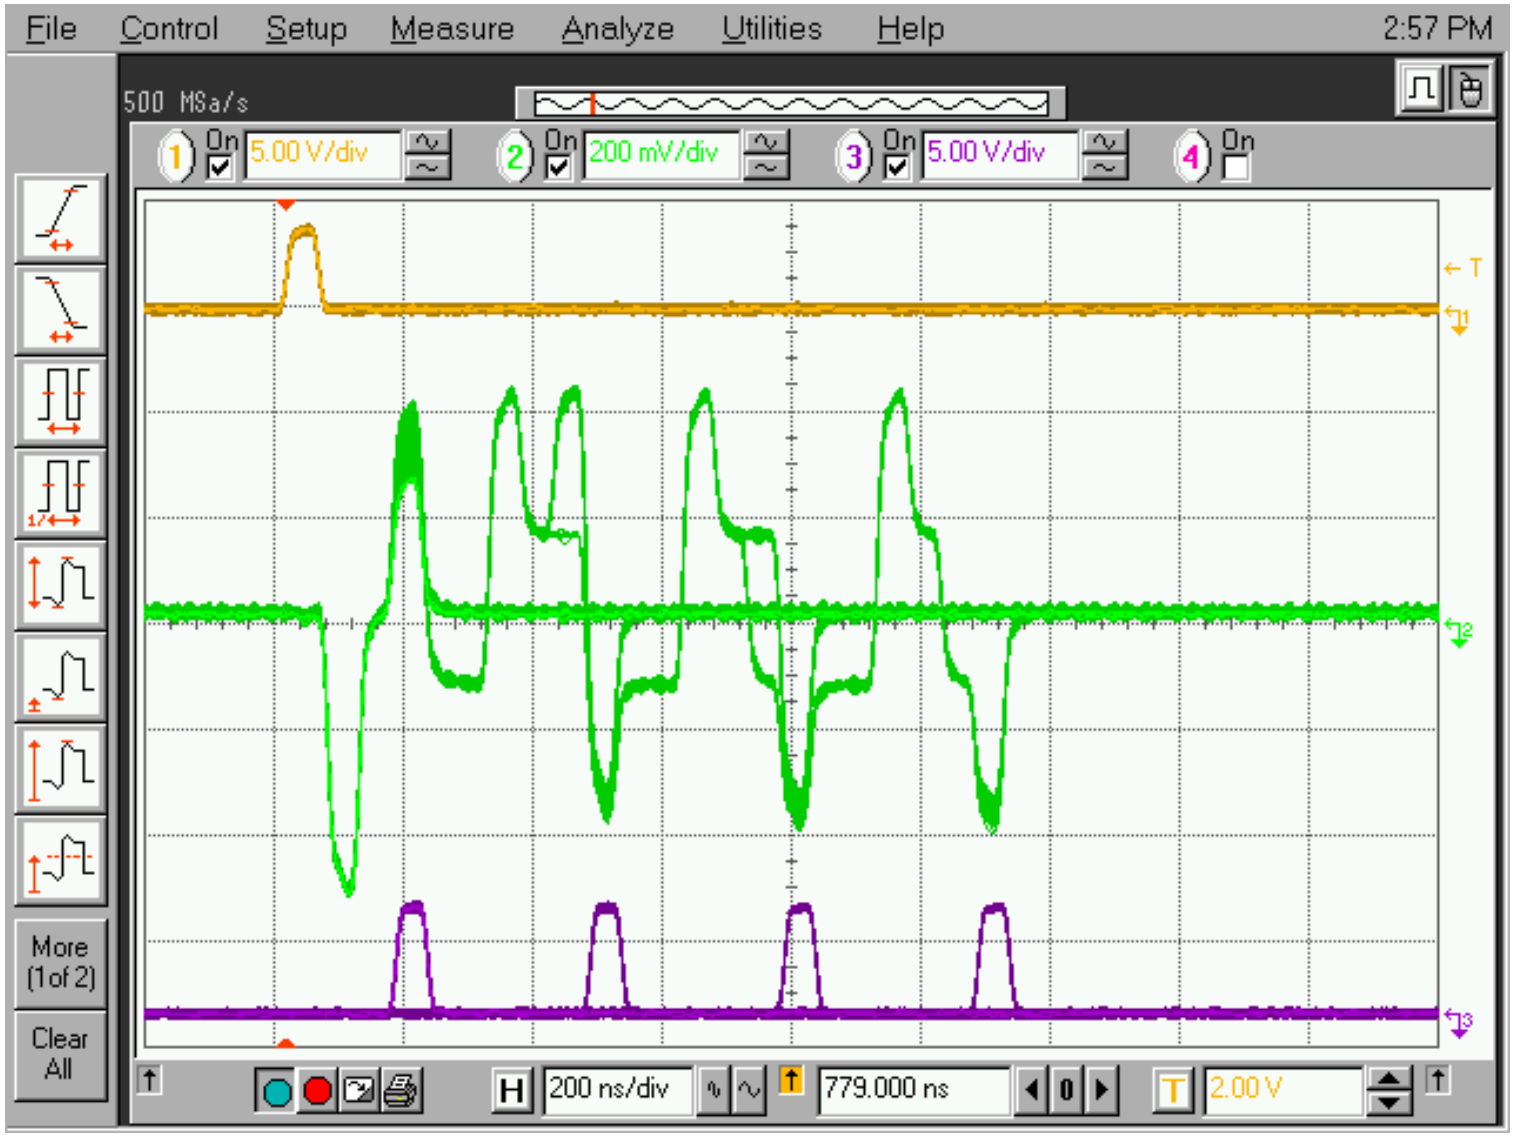
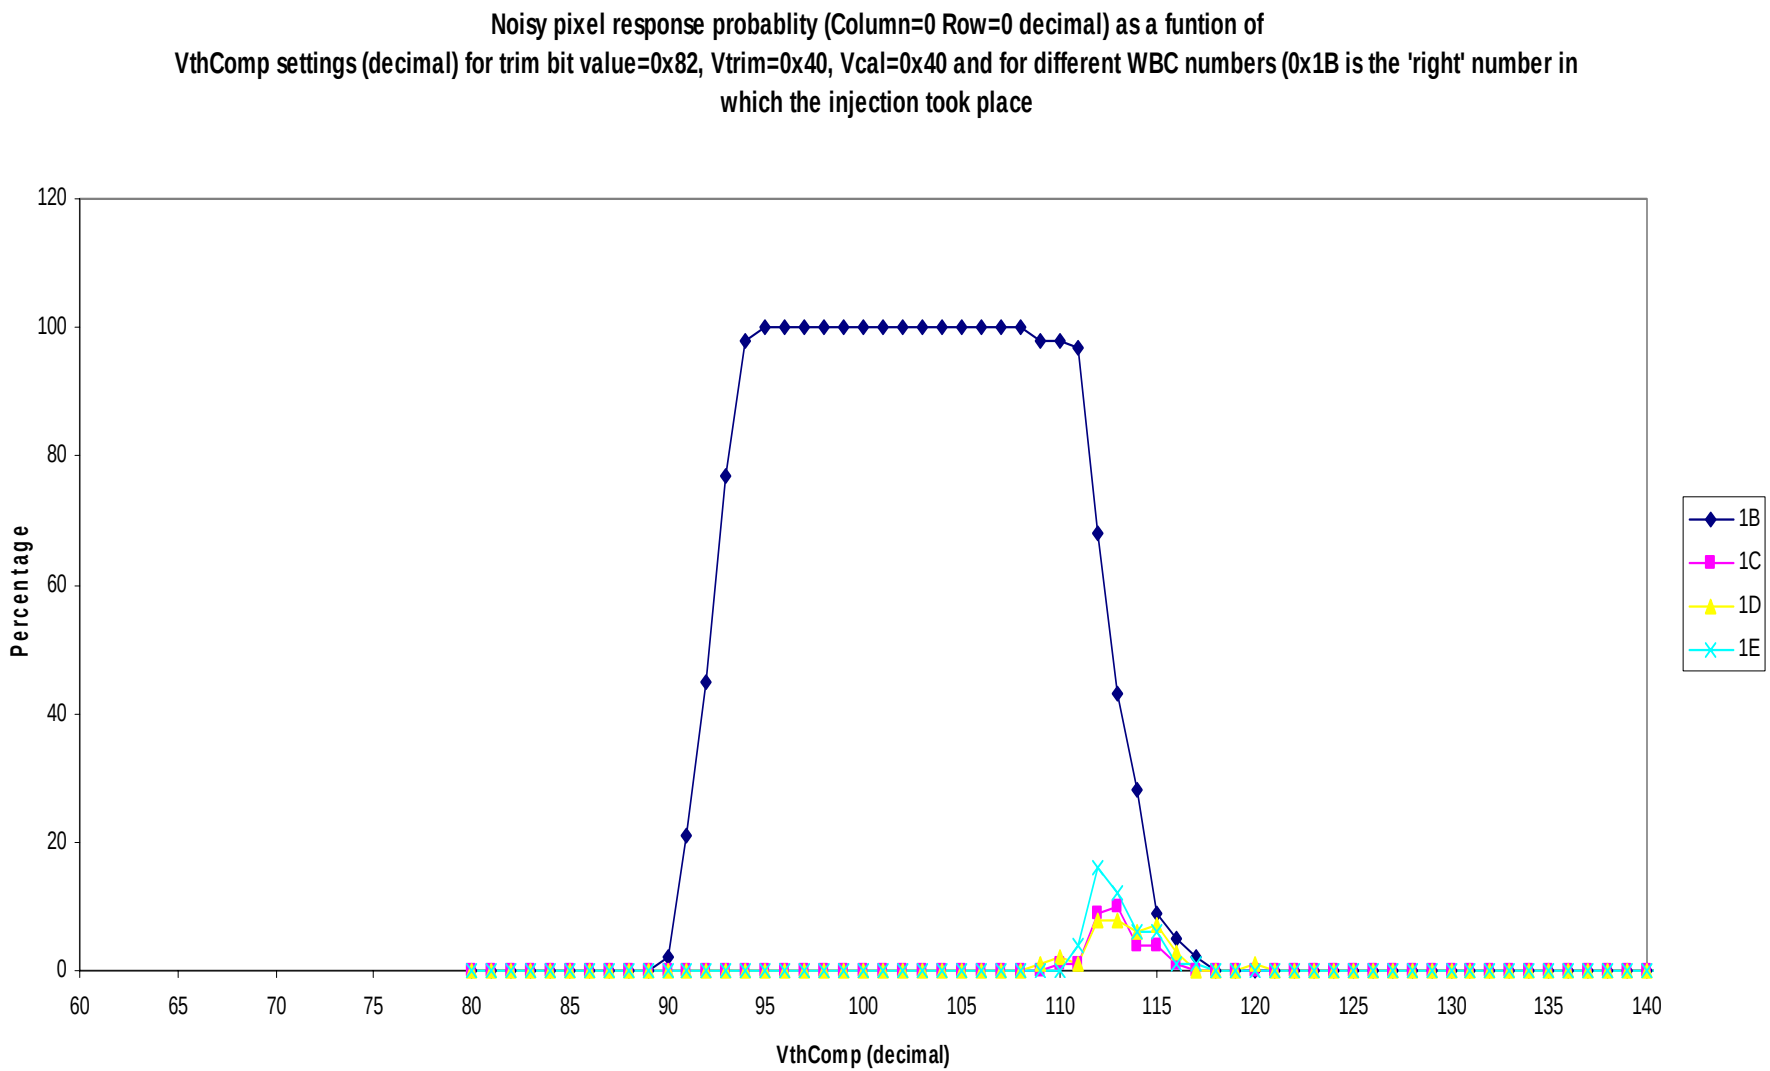
Pixel response dependence on VthComp

- So, I took another approach, which consists in the same enabling and calibrating only one pixel, but doing the readout on some other WBC number, up and down from the one in which I'm injecting. We can see in slide 17 that there are some pixels responses exactly on the window's falling edge.
