CMS Pixel Chip PSI46 V2
- preliminary tests -

Cristian Gingu

Fermilab, February 2005

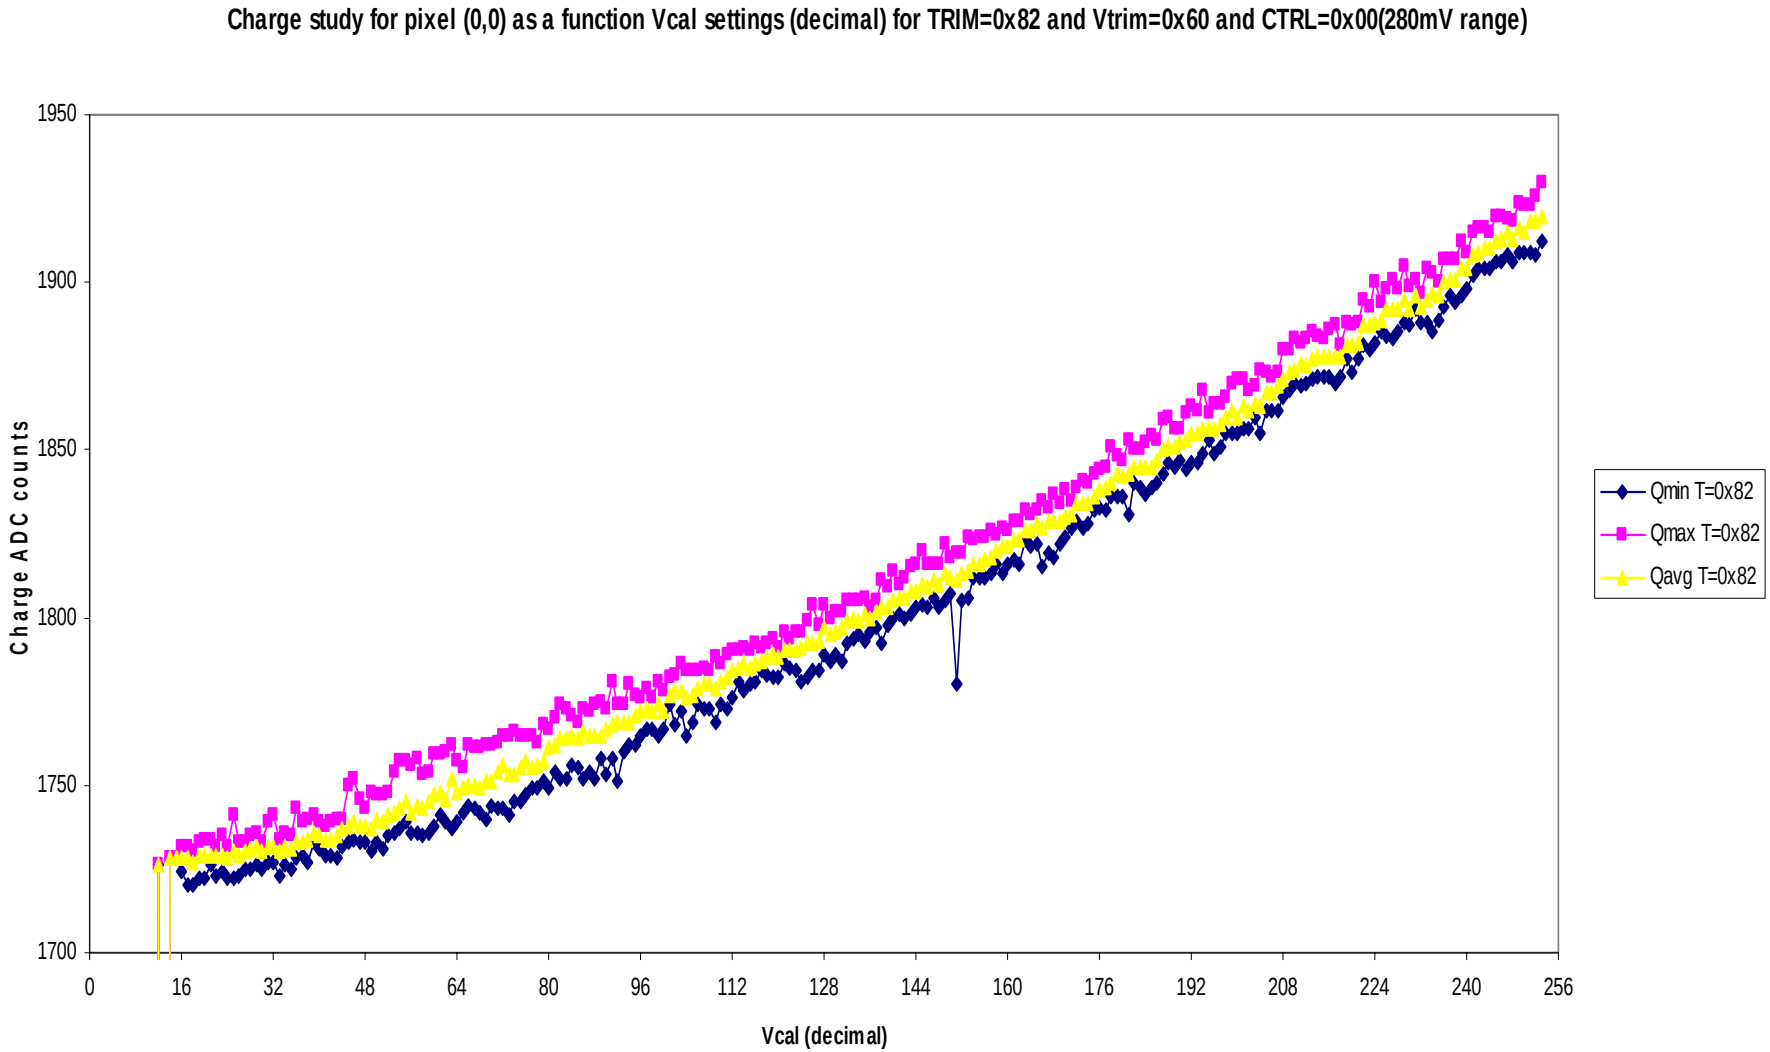
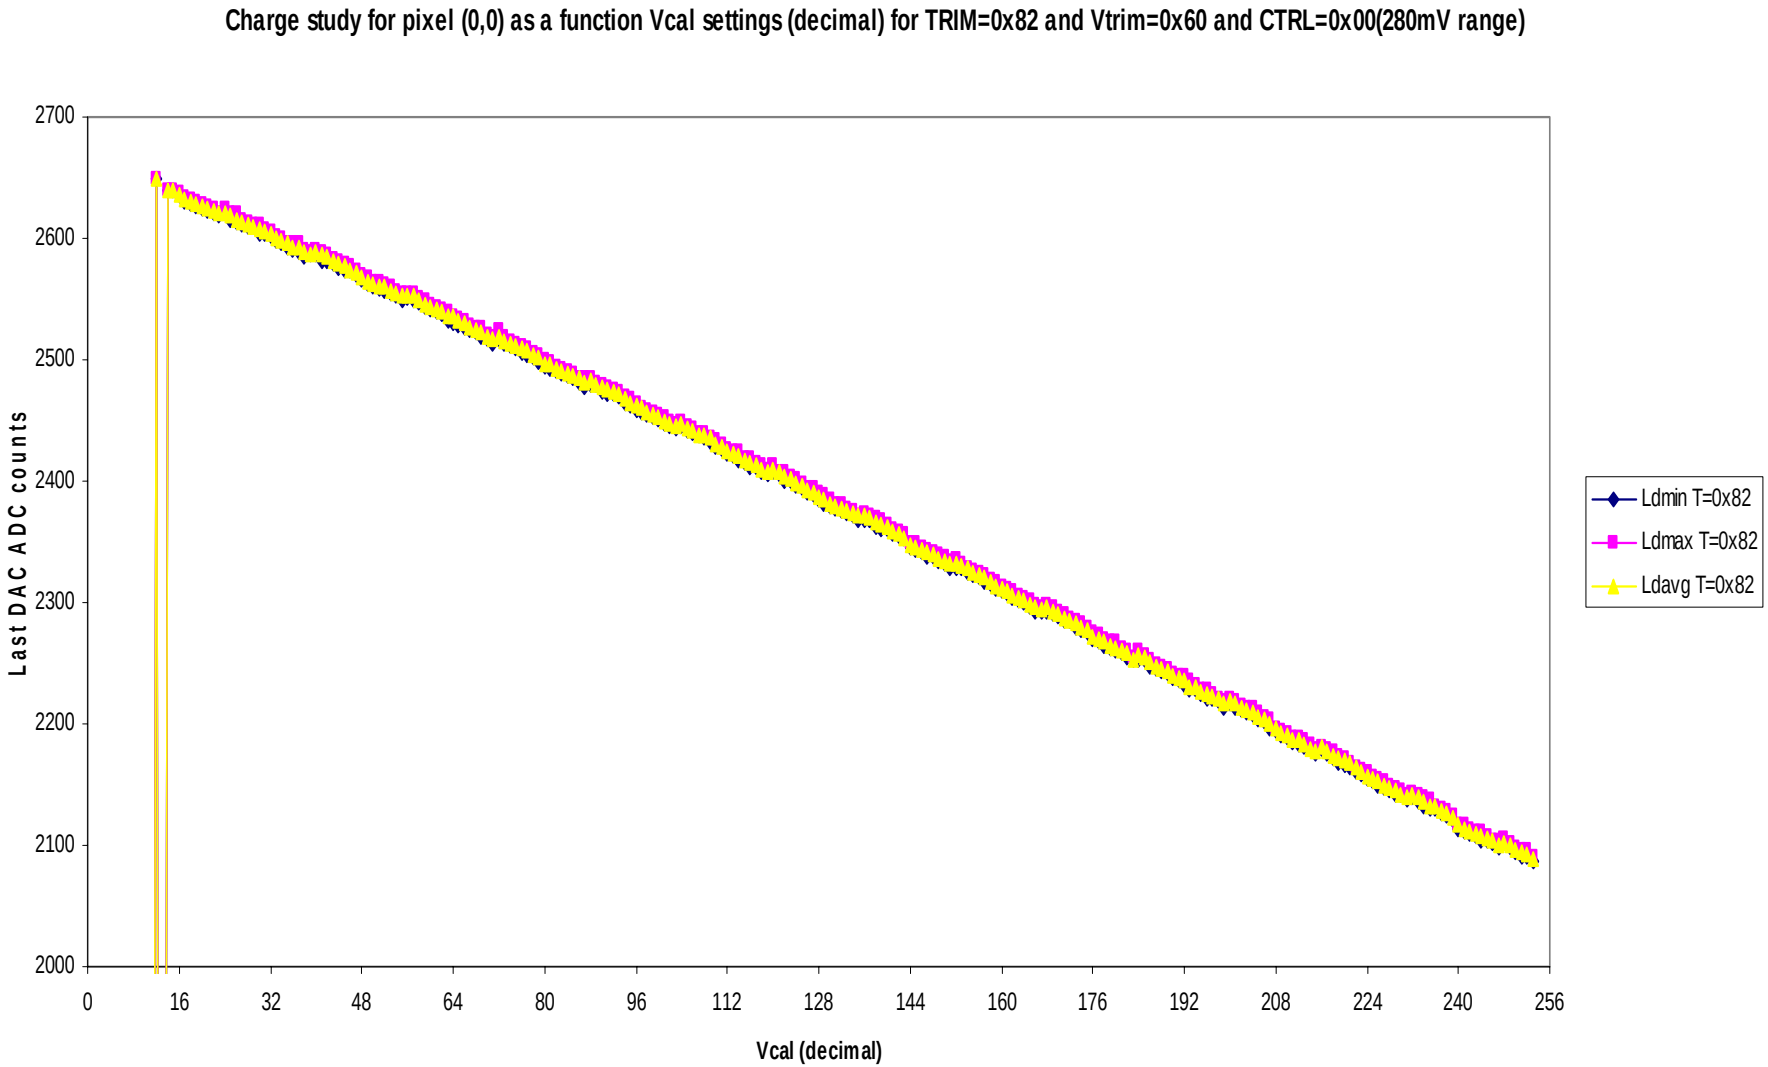
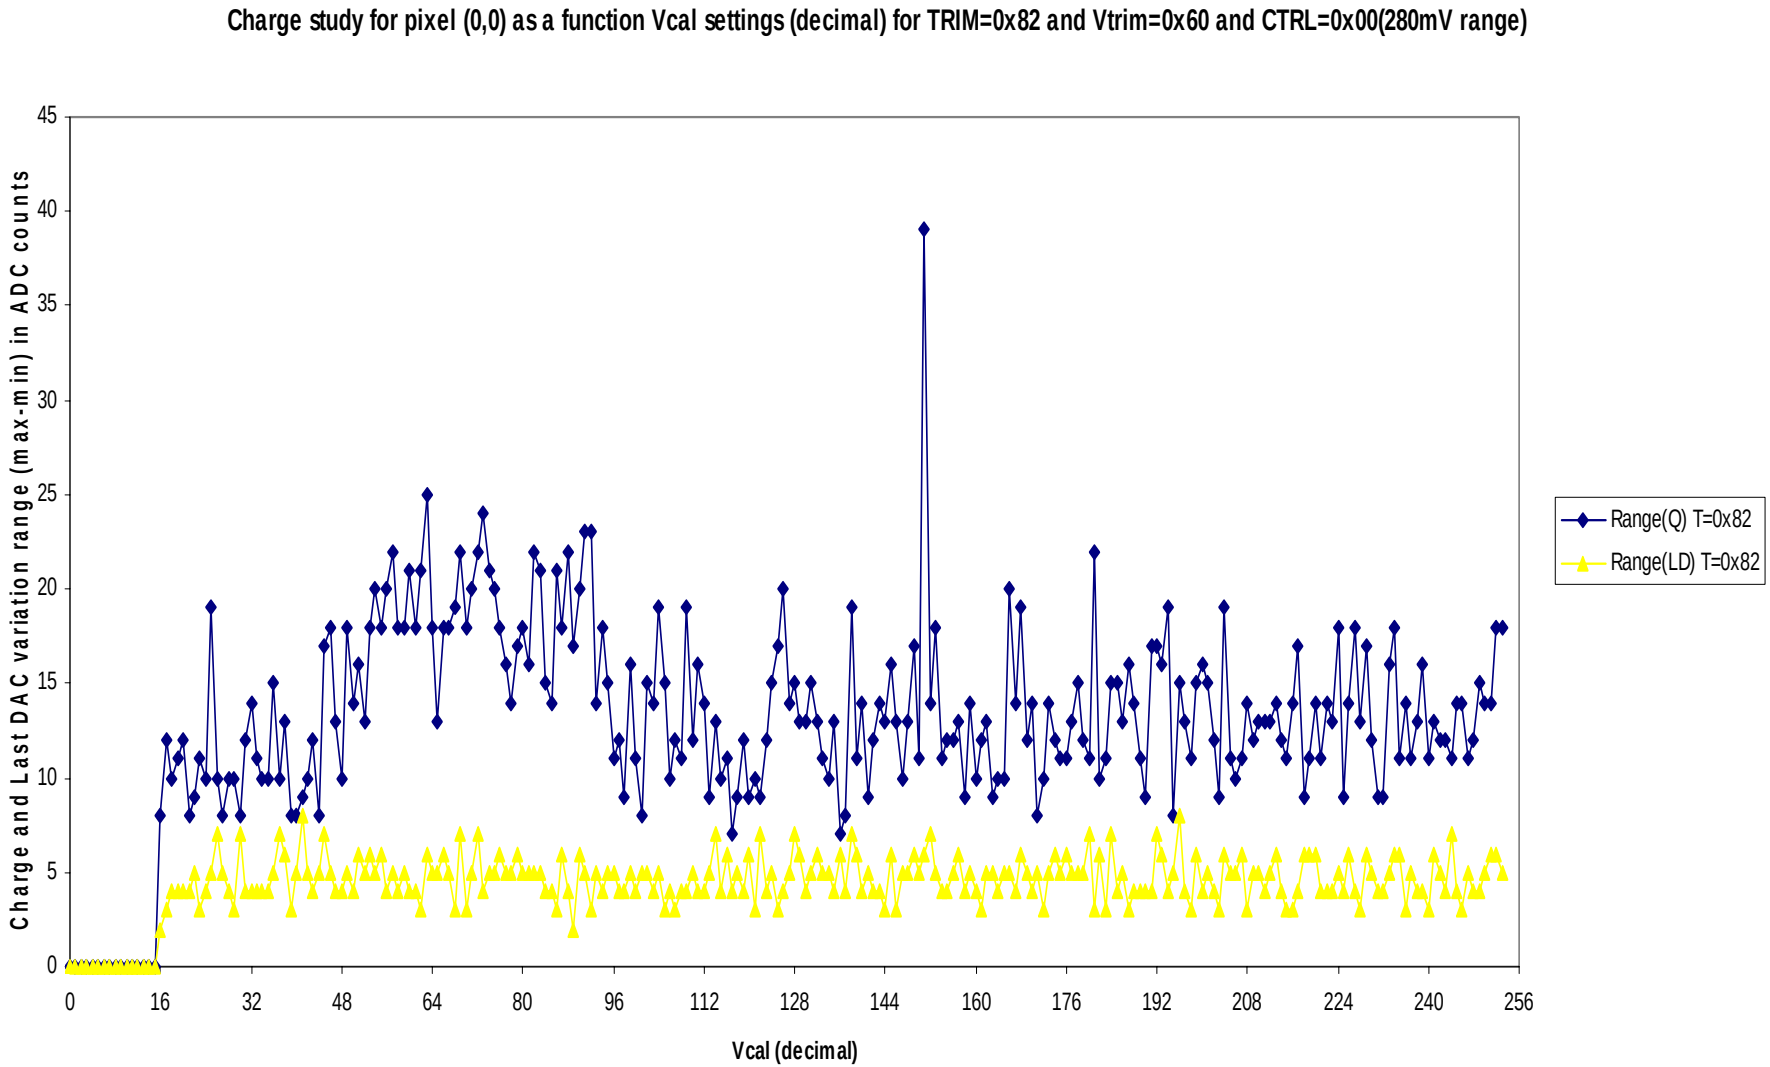
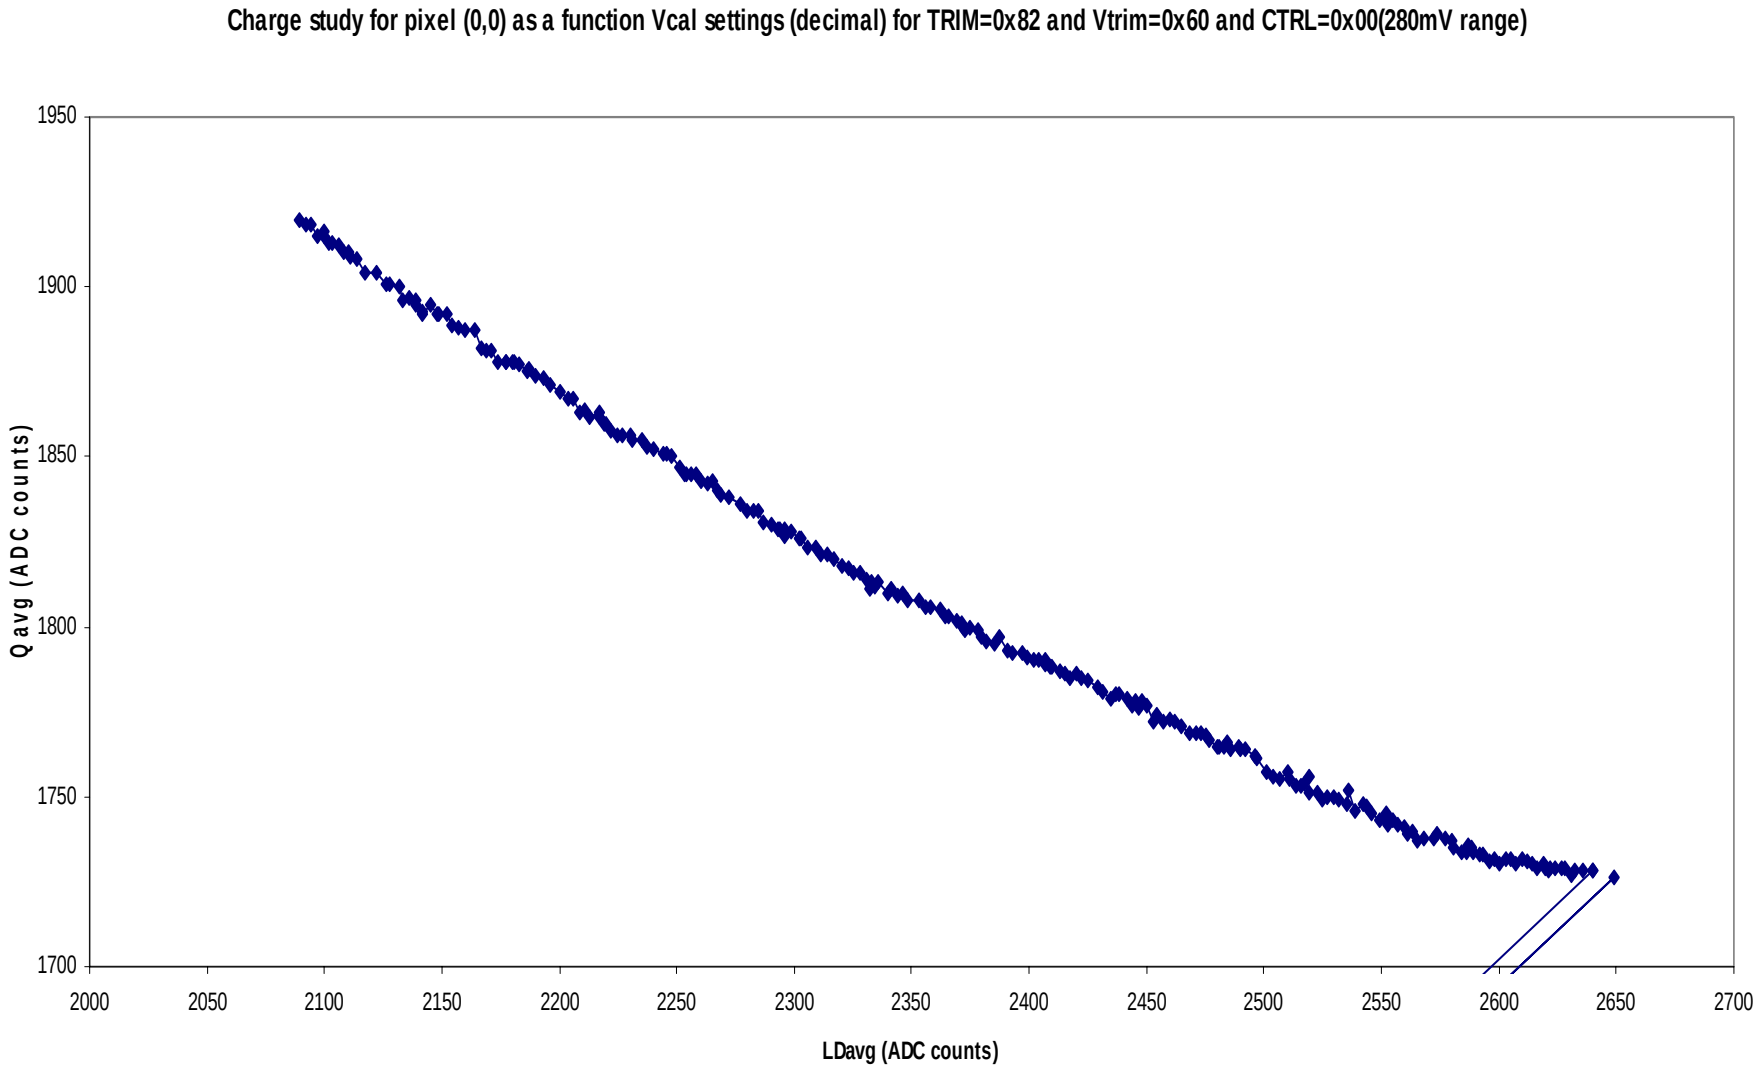
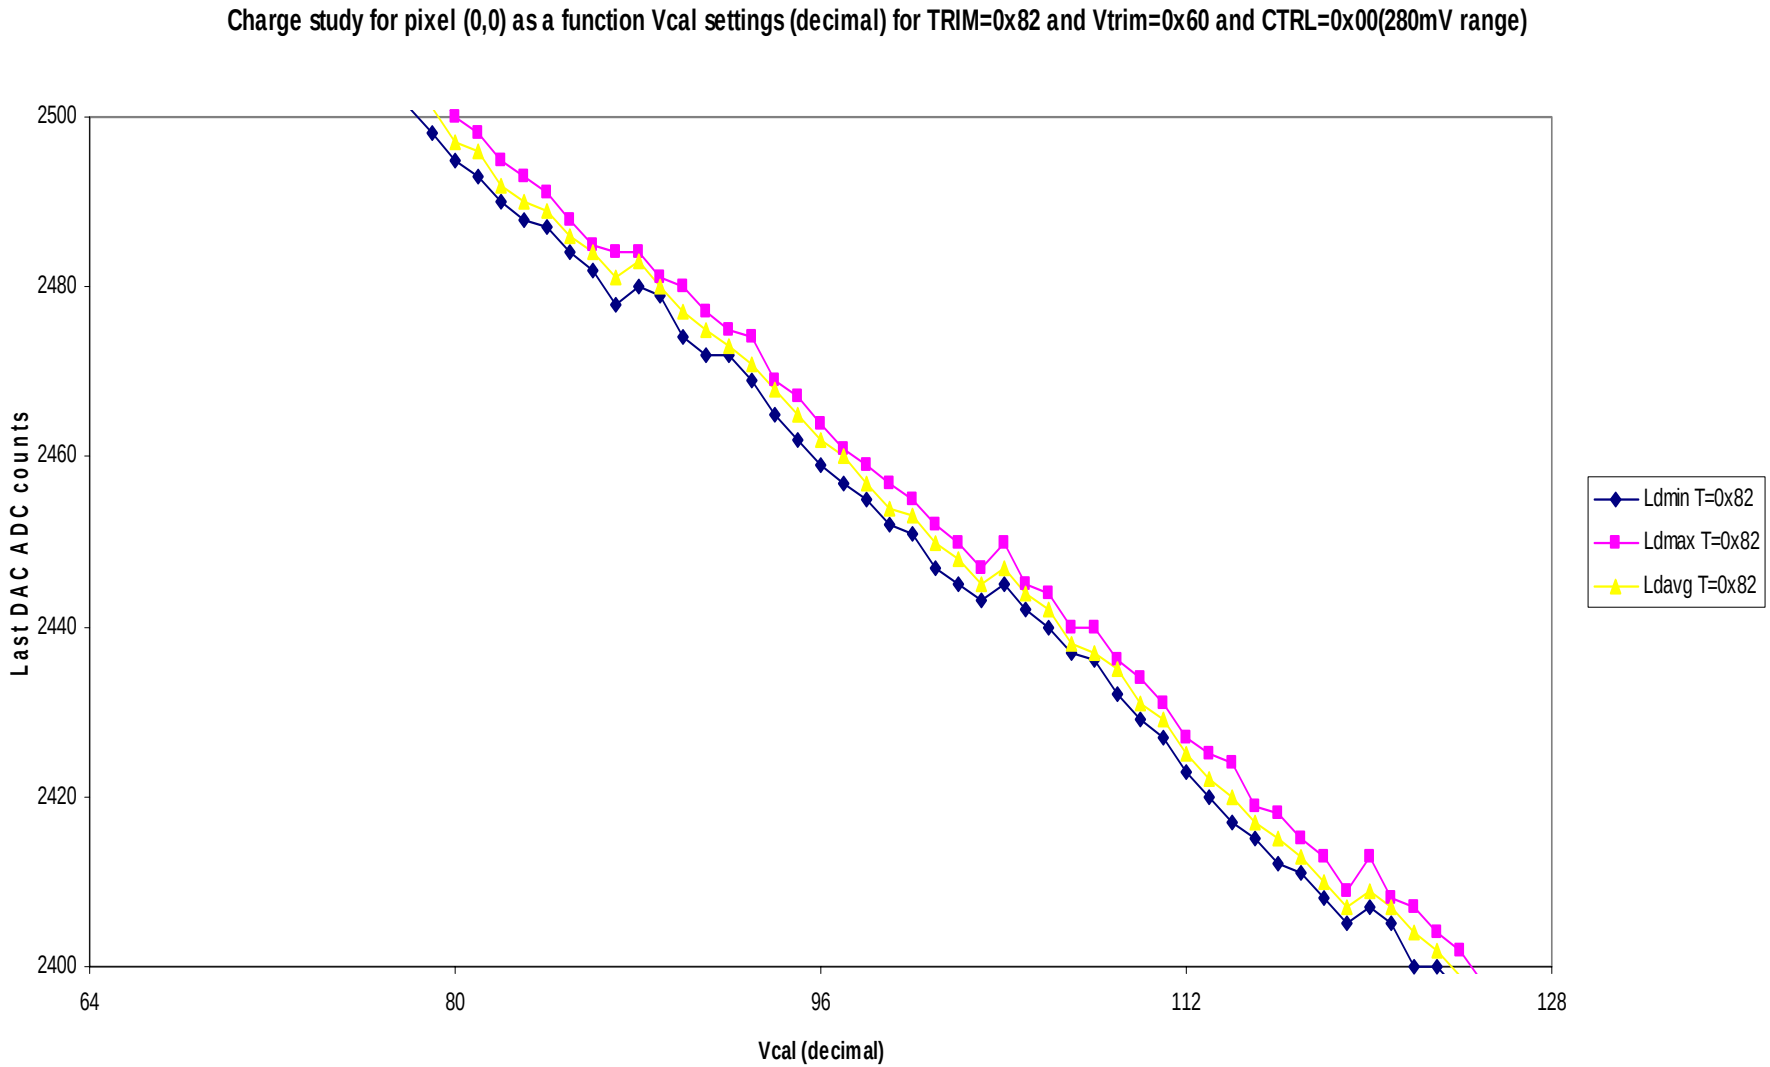
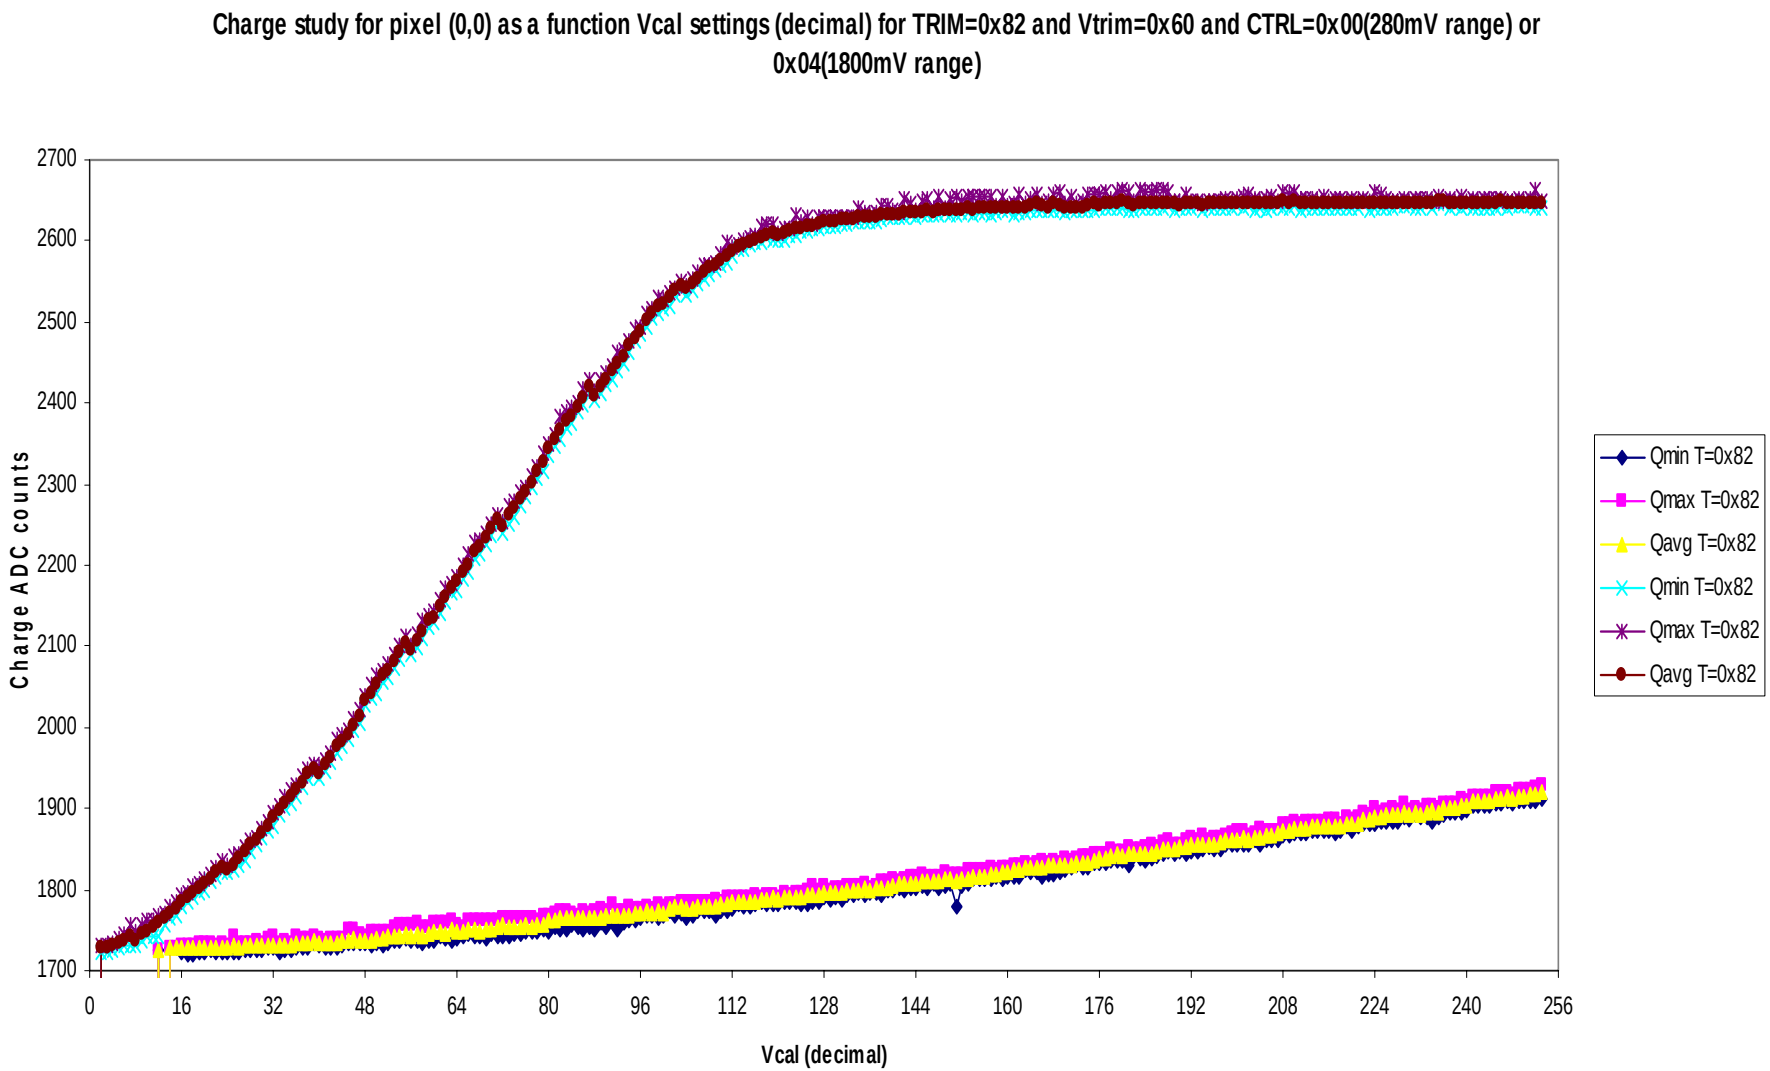
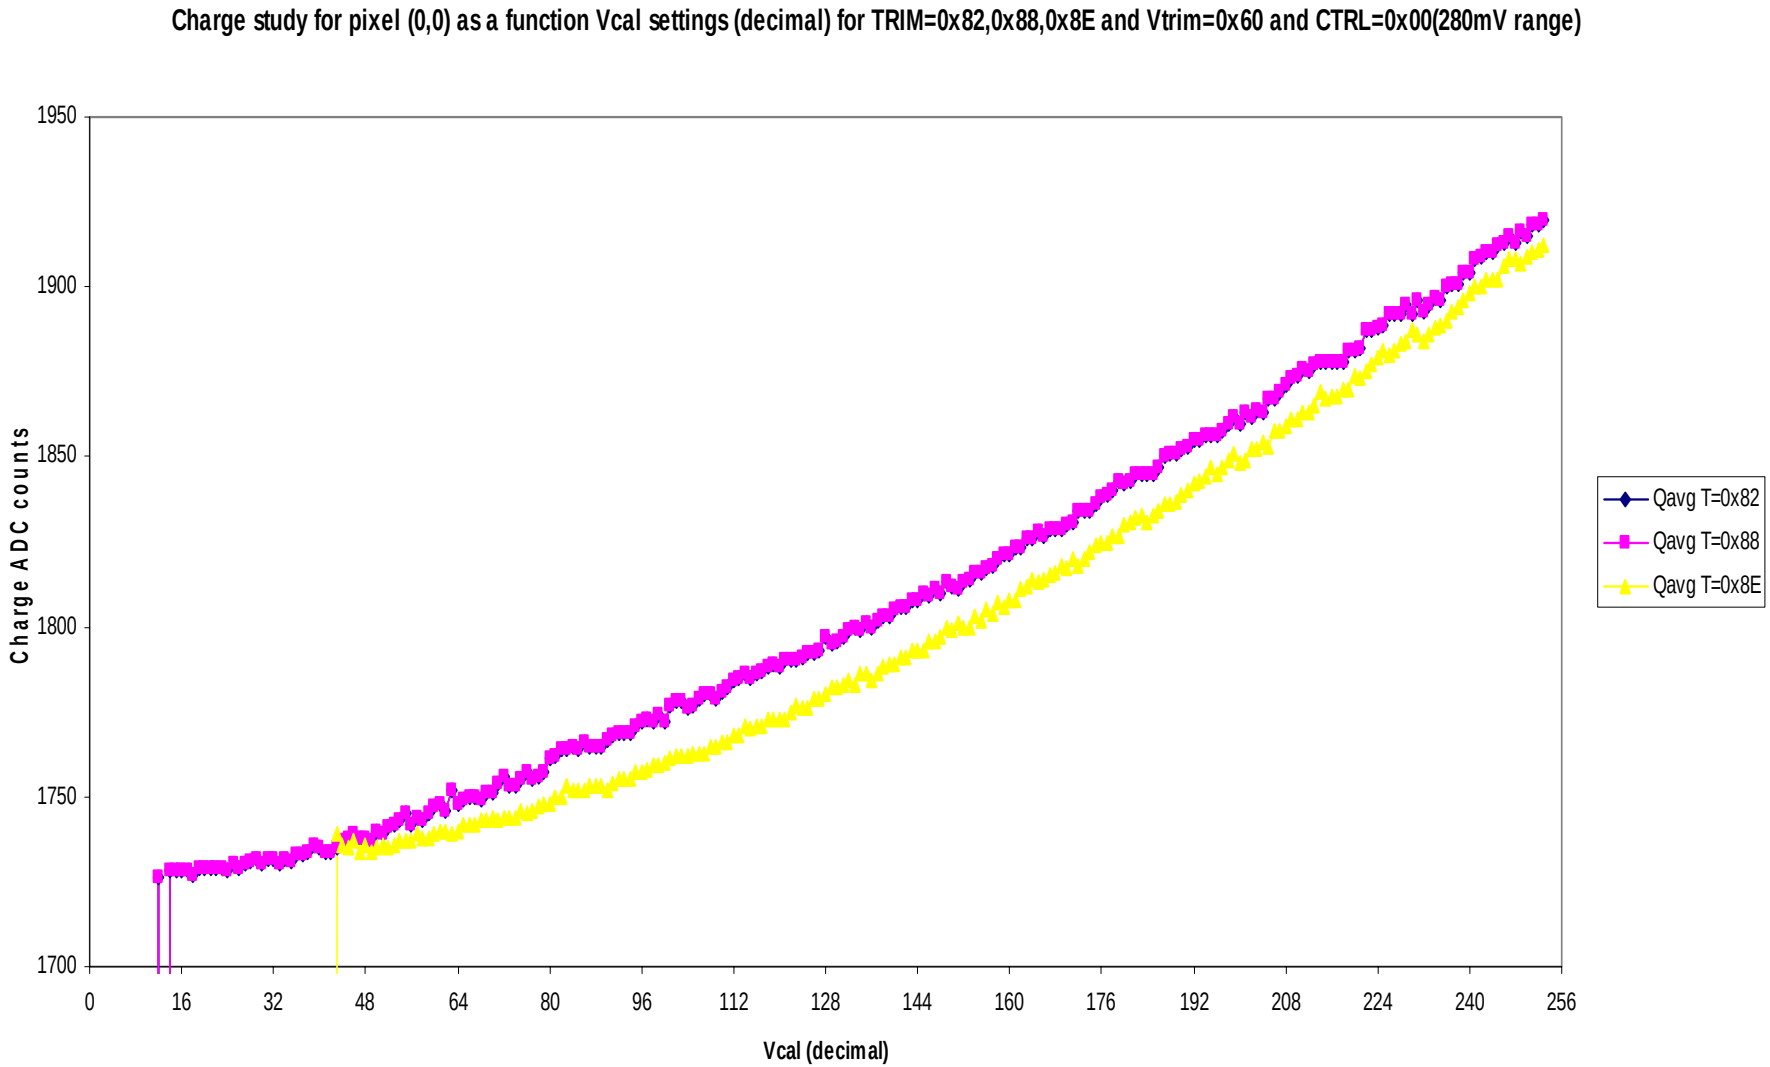
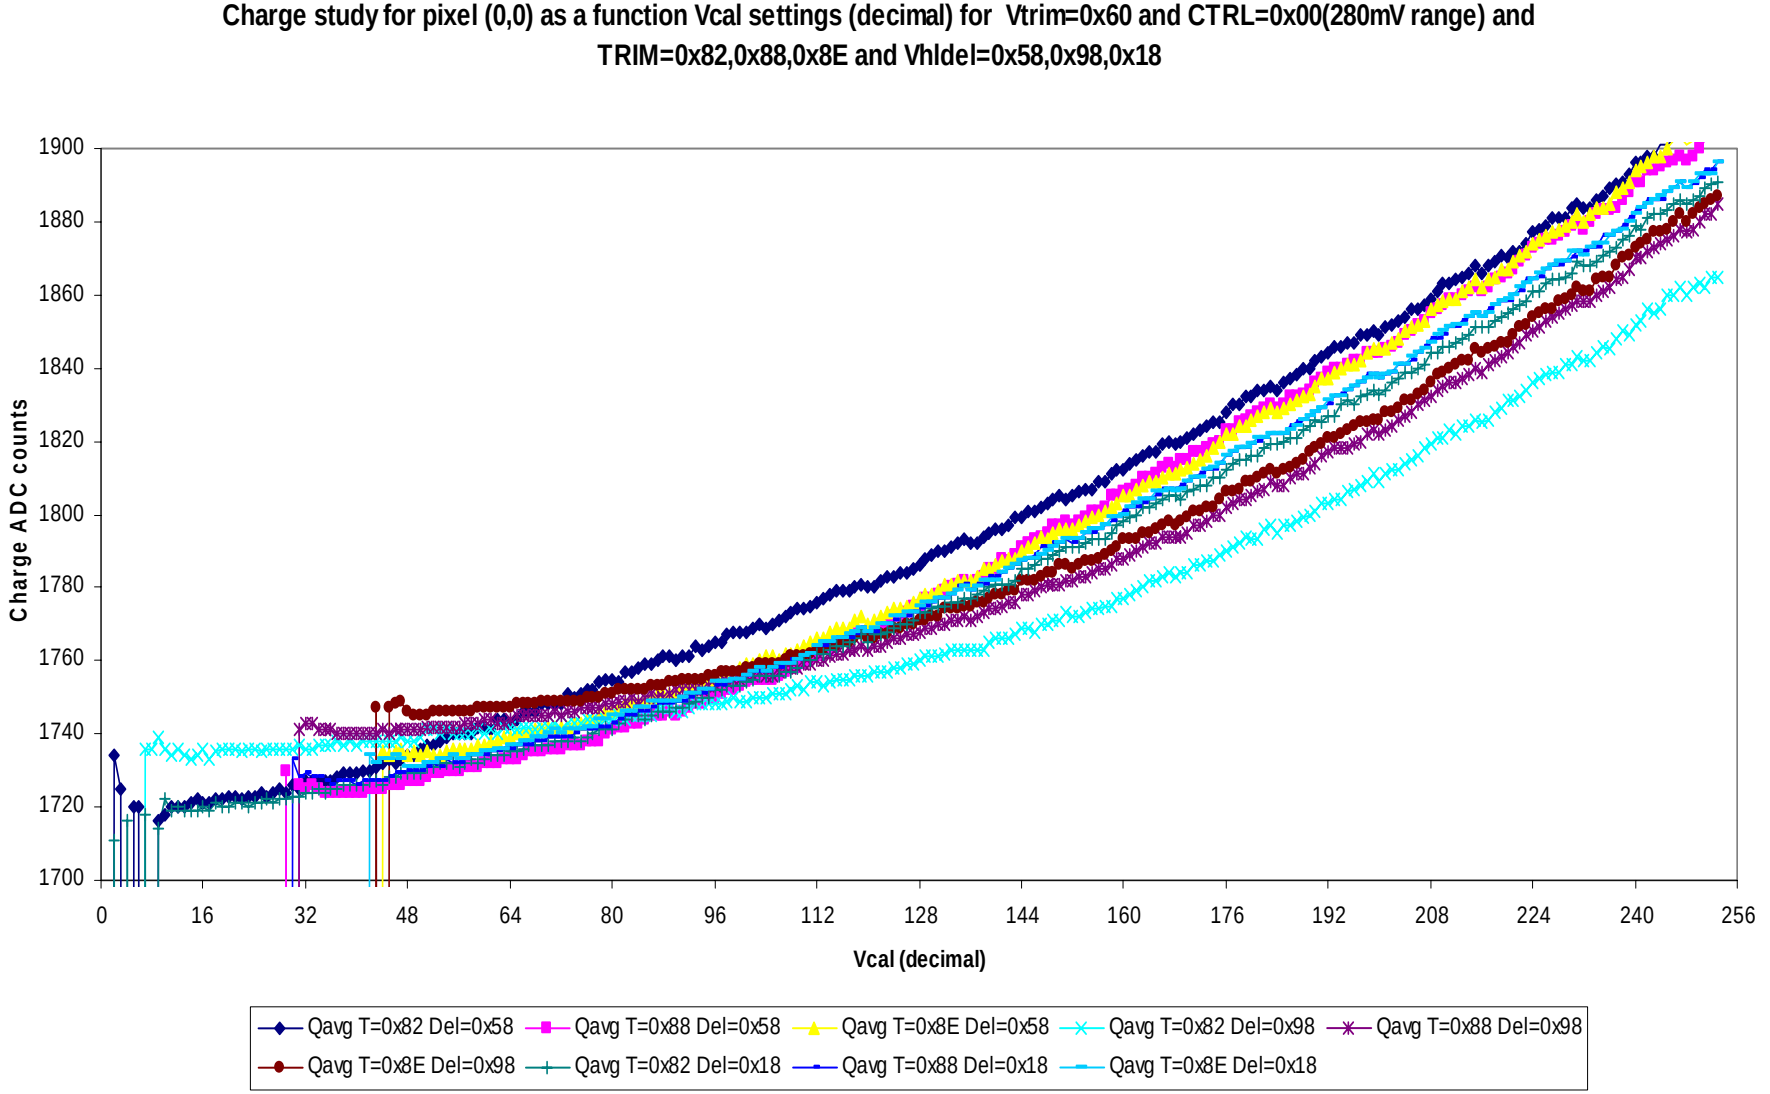
Pixel's charge dependence

- The pixel's readout charge was not investigated in V1 due to a design error that made the readout irrelevant.
- For this new V2 I started to investigate the charge linearity on VCAL for the small range (CTRL=0x04 <-> 280mV). The statistic is the same 100 triggers per pixel measurement conditions.

- On the other hand, it seems that trim bits settings is affecting somehow the readout charge, as shown in slide 25. Ideally the readout charge should not depend on pixel trim bits settings, but slide 25 suggest it does somehow. Rolland H. advised to change VthComp and VHldDel. Changing hold delay register, up and down from the suggested 0x58, as shown in slide 26, did not solve the problem. I haven't tried to change the other register, but if this variation of charge readout with trim bits is not acceptable we need to understand and correct it. I also have no idea how stable is the readout charge is some other DAC settings are changed.

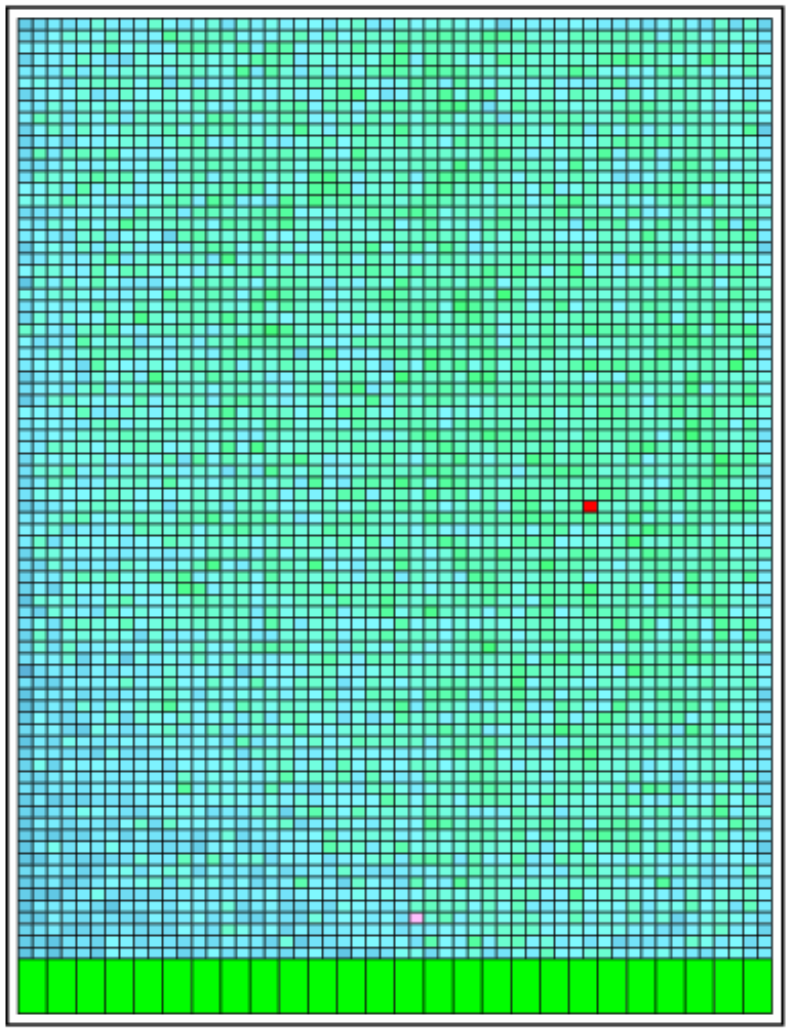
PSI46V2 K7MWH6T/1 03A

- This is chip A59 for us.
- PSI wafer map report say 1 pixel defect

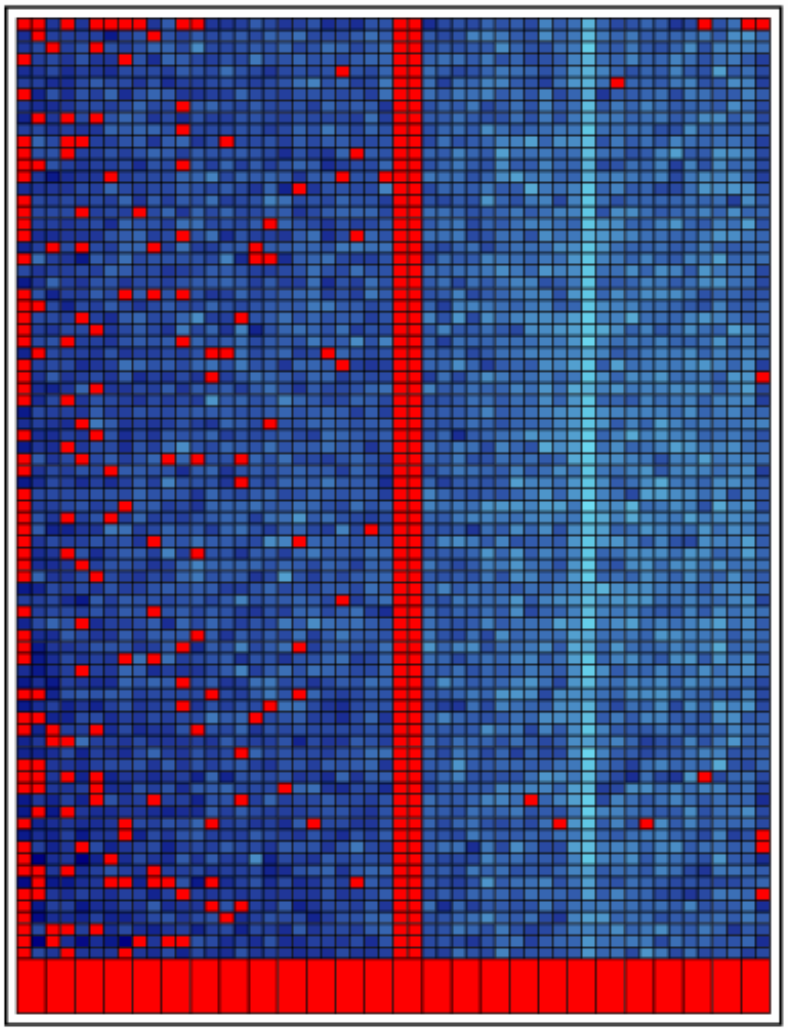
PSI46V2 K7MWH6T/1 04A

- This is chip A60 for us.
- PSI wafer map report say >=5 dcol defect (?)

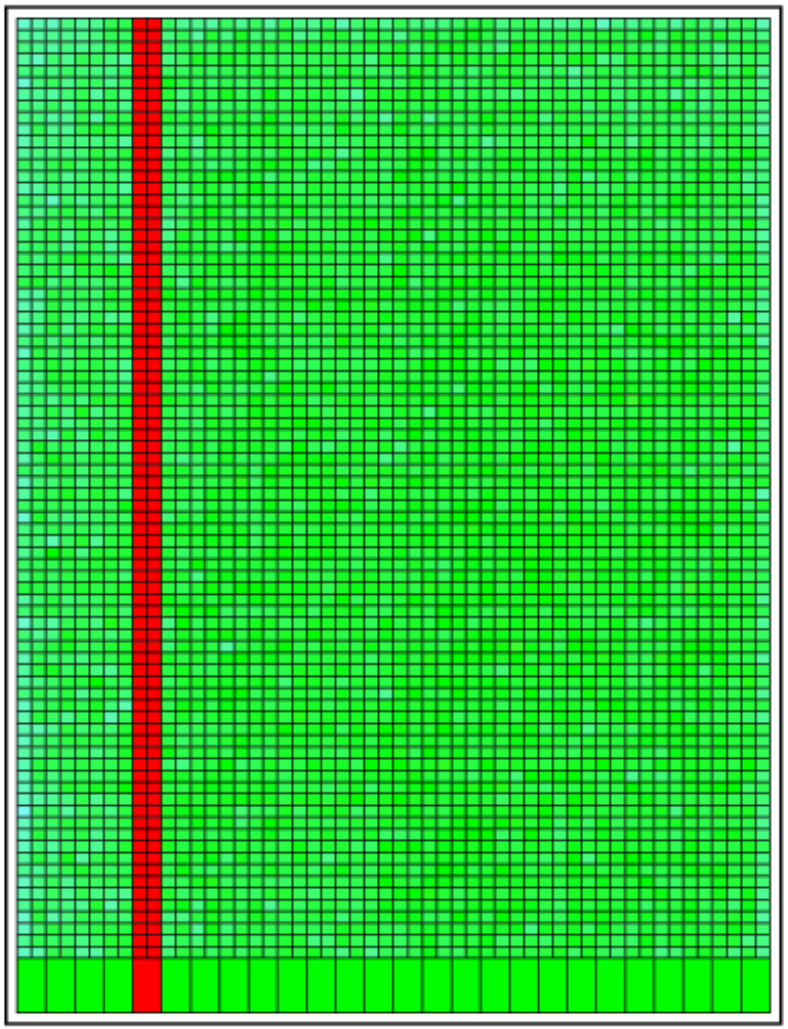
PSI46V2 K7MWH6T/1 17A

- This is chip A57 for us.
- PSI wafer map report say 1 dcol defect
- FNAL found an additional pixel defect

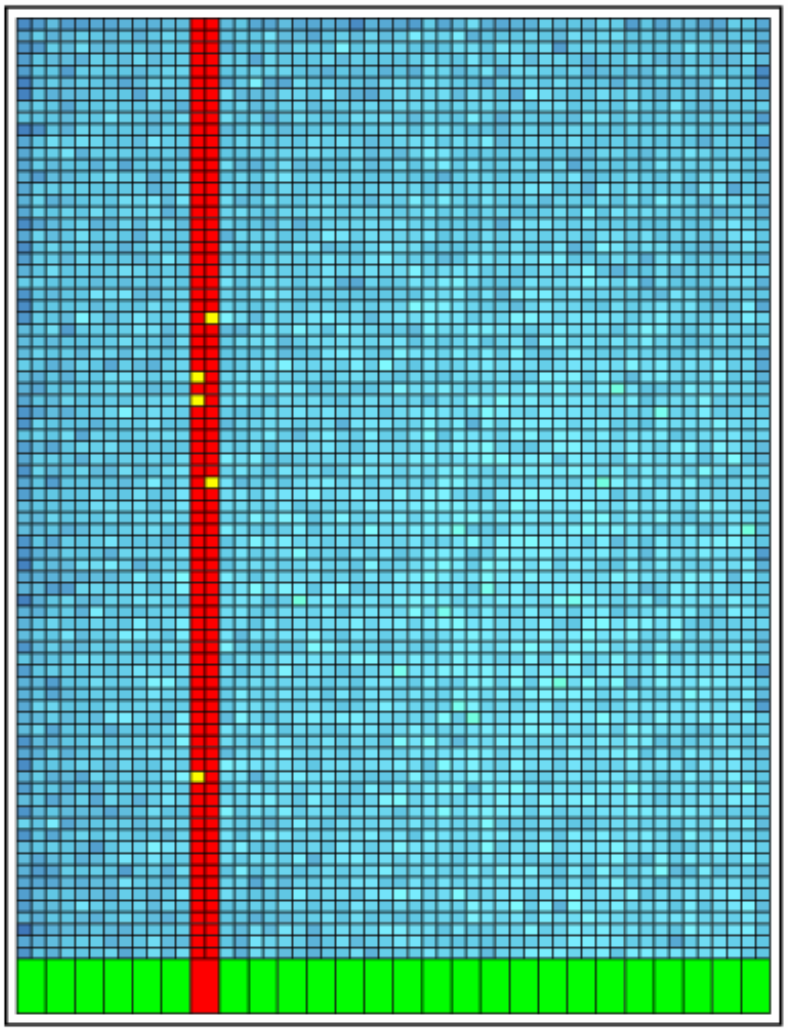
PSI46V2 K7MWH6T/1 16A

- This is chip A56 for us.
- PSI wafer map report say 1 dcol defect

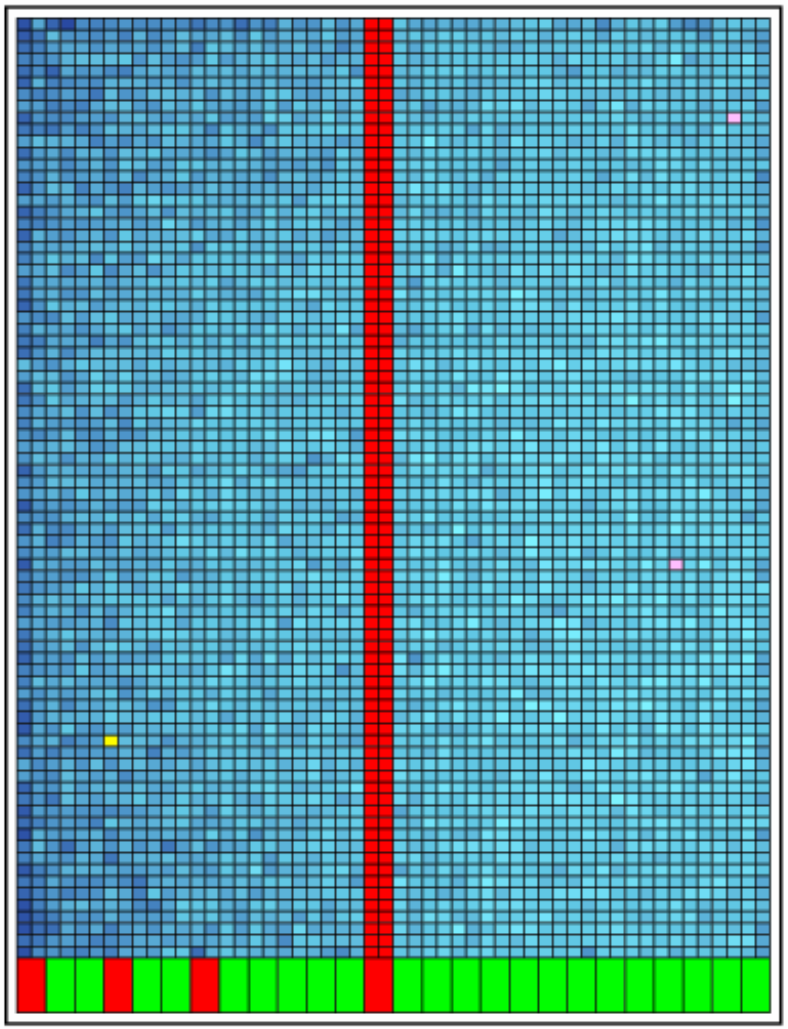
PSI46V2 K7MWH6T/1 15A

- This is chip A55 for us.
- PSI wafer map report say 2…4 dcol defect (?)
- FNAL one test shows oscillations from COL27 up
- FNAL second test shows two more pixels defective
- The agreement between tests is questionable here

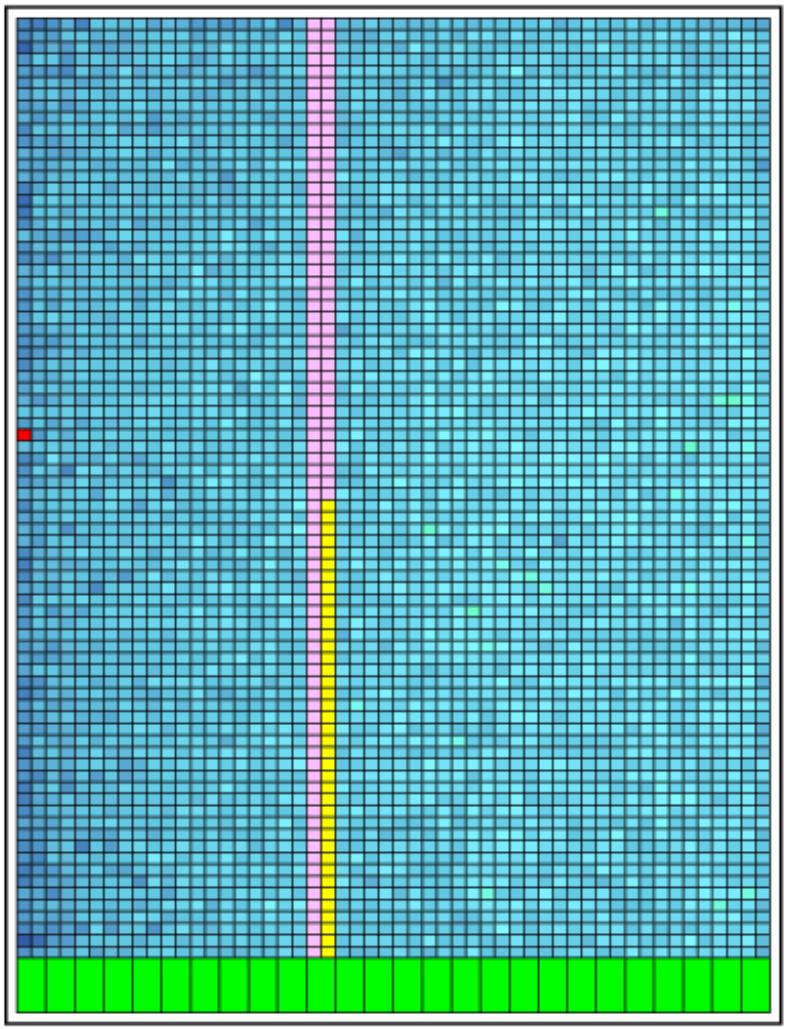
PSI46V2 K7MWH6T/1 14A

- This is chip A54 for us.
- PSI wafer map report say >= 30 pixels defect (?)
- FNAL shows 2 columns plus 3 more pixels defect
- The agreement between tests is questionable here

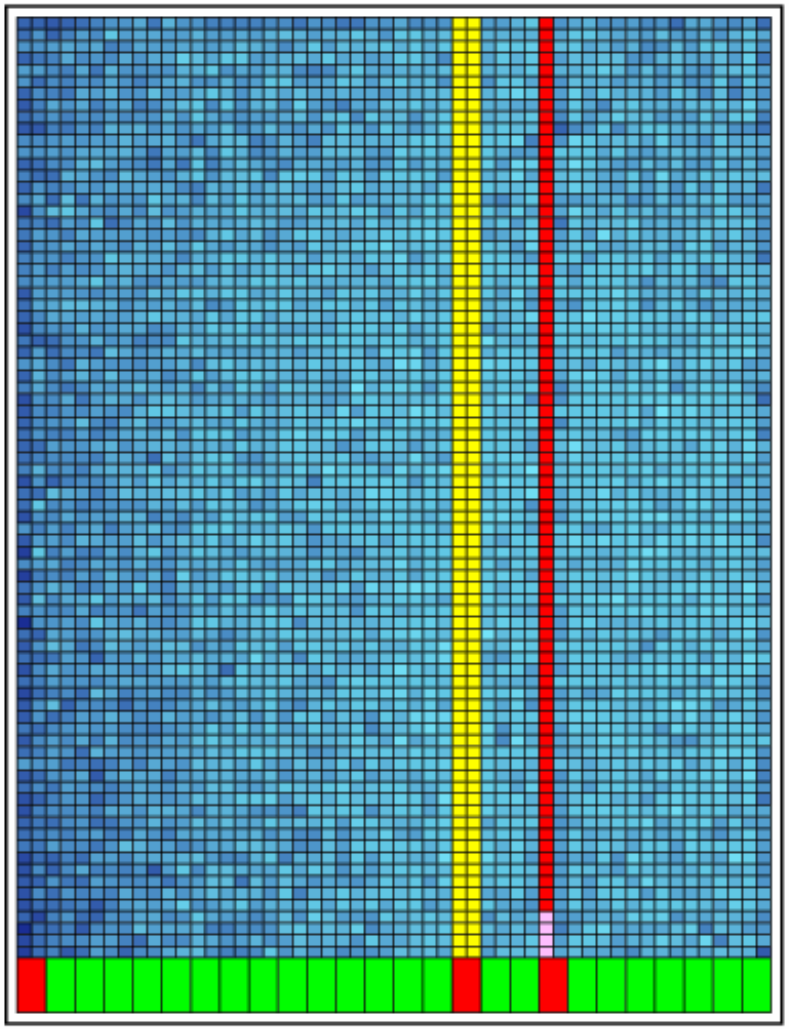
PSI46V2 K7MWH6T/1 12A

- This is chip A52 for us.
- PSI wafer map report say 2…4 dcol defect (?)
- FNAL shows only 2 pixels defect (wrong address levels)
- We disagree completely here

- Retesting the chip, with different settings, give us almost the same result
- Conclusion is that we disagree complete here
