# PPD's News to Live By

ES&H Newsletter  
November 2011

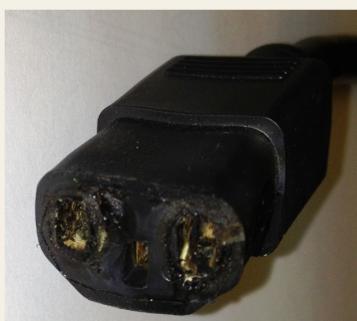
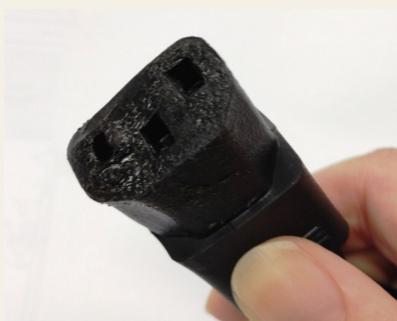
## Melted Electrical Plugs

While Dervin Allen's technical crew was deconstructing the CDF first floor electronics room, two CAMAC crates were found with power plugs that were essentially melted. Dervin was surprised we did not have some sort of electrical incident. The plugs were given to Angela Sands for a lessons learned on a near miss analysis.

The plugs and crates had been in use for over 20 years, and it appears that there was likely a loss in spring tension, which caused increased resistance and heat.
